Aging management program of the reactor building concrete at Point Lepreau Generating Station

Abstract. In order for New Brunswick Power Nuclear (NBPN) to control the risks of degradation of the concrete reactor building at the Point Lepreau Generating Station (PLGS) the development of an aging management plan (AMP) was initiated. The intention of this plan was to determine the requirements for specific structural components of concrete of the reactor building that require regular inspection and maintenance to ensure the safe and reliable operation of the plant. The document is currently in draft form and presents an integrated methodology for the application of an AMP for the concrete of the reactor building. The current AMP addresses the reactor building structure and various components, such as joint sealant and liners that are integral to the structure. It does not include internal components housed within the structure. This paper provides background information regarding the document developed and the strategy developed to manage potential degradation of the concrete of the reactor building, as well as specific programs and preventive and corrective maintenance activities in

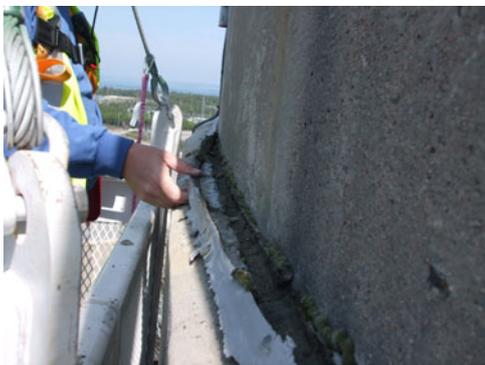
- *Failure of the joint sealant*, which is either debonded from the concrete, loose, or missing at nearly all of the joints of the ring beam, or weathered, dry, cracked and debonded from the concrete in several areas at the joint between the dome and upper ring beam. As pointed out in the strategy of the draft AMP degradation failure of the joint sealant is a precursor to other potential degradation mechanisms. Failure of the sealant at the joint between the top of concrete overlay and the upper ring beam has allowed water to penetrate into the joints and caused leaching of some materials along the joints, or allowed the water to be trapped and be channeled behind the overlay. Figures 1 and 2 show failure of the joint sealant between the top of the concrete overlay and the upper ring beam, which has permitted the accumulation of sediment and facilitated the growth of organic material. GPR survey and drilling suspect areas in the concrete overlay revealed small areas soft, moist, or water saturated concrete, in some of the cable box-outs which is most likely the result of poor consolidation during construction and failure of the sealant at the top of the overlay.

Figure 1. Failed sealant at joint between the top of concrete overlay and upper RB ring beam.

- *Sealant replacement.* COG qualified and accepted material [10] was used for sealant replacement of the horizontal joint between the concrete overlay and the ring beam, as well as of all the vertical construction joints in the ring beam concrete overlay (Figures 7 and 8).

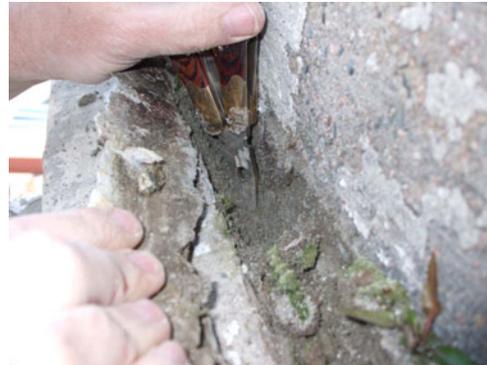
Figure 2. Configuration of joint top concrete overlay showing sealant failure.

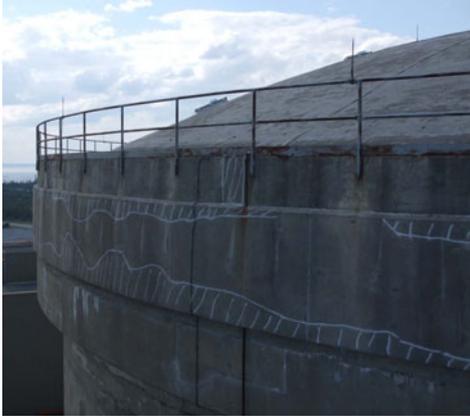
- *Delamination of the non-structural concrete* overlay of the ring beam. A significant amount of debonding was revealed by hammer sounding on the concrete overlay. The delaminations typically extend 300-400 mm up from the bottom of the overlay and 150–200 mm down from the top edge. The delaminated areas were delineated and identified on the structure, as shown in Figure 3, and are an artifact of the original construction detail.

Figure 3. Delamination of non-structural concrete overlay of the ring beam.

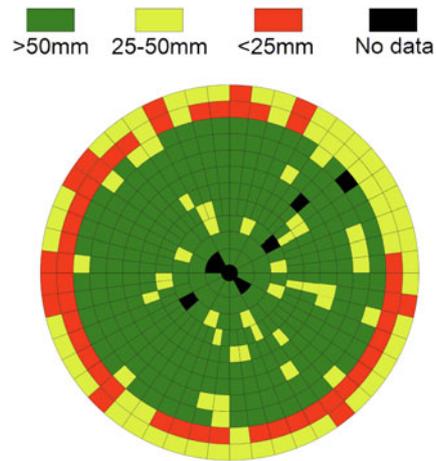
- *Concrete cover* over the reinforcing steel of the dome *below the normally specified thickness 50 mm*. GPR equipment was used to continuously scan twelve concentric circles of the survey grid. Figure 4 presents a map of the minimum concrete cover of the dome, where in each element represented there is at least one rebar with the minimum cover indicated. The survey identified significant areas of thin concrete cover, with an average cover ranging between 25 mm and 50 mm, including the outer 3–4 meters of the dome. The low concrete cover of the outer ring of the dome is likely caused by the difficulty of placing concrete due to the geometry of the dome. Reinforcing steel corrosion potential testing on the dome and ring beam, determined by the half-cell corrosion potential method following ASTM C876 [13] revealed a 90% probability that corrosion is not occurring in the steel reinforcement. Of the over 1200 readings taken, none indicated potential for corrosion to be present in the embedded reinforcement. Concrete samples recovered from the dome and ring beam were tested in the laboratory for chloride ion content following ASTM

Figure 4. Map showing minimum concrete cover of the RB dome.

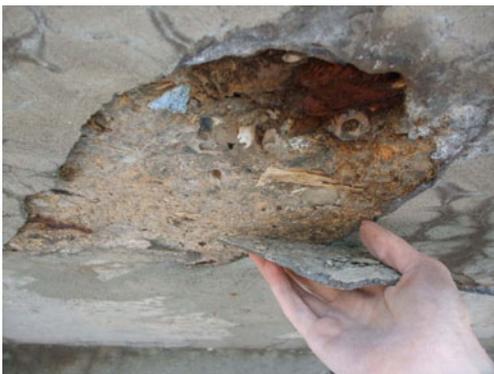
- *Embedded contamination of the concrete* of the ring beam, in the form of lumber, wood chips, saw dust, nails, wire, plastic etc, has caused some localized distress to the structural concrete at various locations in the structure (Figure 5).

Figure 5. Embedded contamination on soffit of lower ring beam including foam insulation, wood chips, saw dust, steel nut and nails.

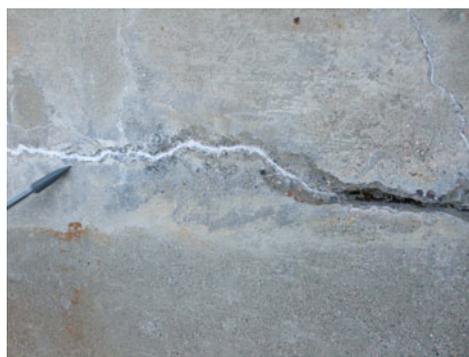
Figure 6. Crack filled with mineral deposits in the ring beam.

- *Concrete cracks filled with mineral deposits.* Cracking was more severe in the ring beam, ranging from hairline cracks to 1 mm crack width, than in the dome, where only limited hairline cracks were observed (Figure 6).
- *Concrete topping which is weathered, eroded and missing* on approximately 50% of the dome.

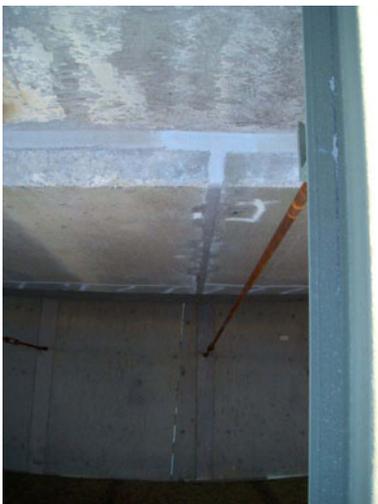
Figure 7. Repaired joint sealant (horizontal and vertical) of the concrete overlay.

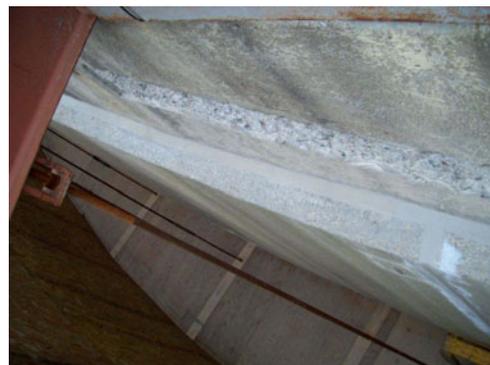
Figure 8. A shallow repair area above the joint between the concrete overlay and the ring beam and repair sealant.

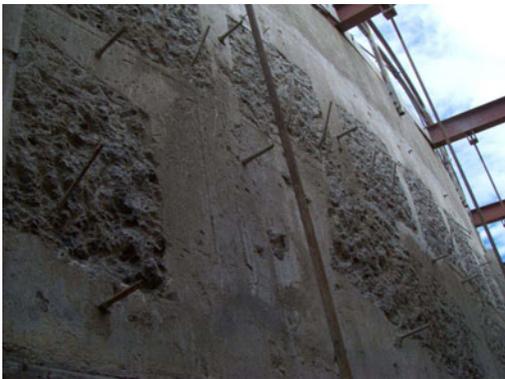
Figure 9. Face of the ring beam with box-outs after removal of a section of the concrete overlay.

- *Post tension box-outs repairs.* Concrete was replaced in all box-outs that are above the elevation of the horizontal joint of the concrete overlay and the ring beam. Figure 9 presents an intermediate repair step after removal of concrete. Figure 10 presents a feathered edge box-out repair completed.

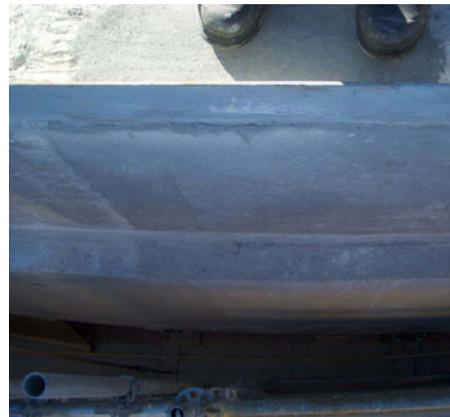
Figure 10. Feathered edge box out after repair.
