## Integrity assessment of grouted posttensioning cables and reinforced concrete of a nuclear containment building

**Abstract.** The Containment Buildings of CANDU Nuclear Generating Stations were designed to house nuclear reactors and process equipment and also to provide confinement of releases from a potential nuclear accident such as a Loss Of Coolant Accident (LOCA). To meet this design requirement, a post-tensioning system was designed to induce compressive stresses in the structure to counteract the internal design pressure. The CANDU reactor building at Gentilly-1 (G-1), Quebec, Canada (250 MWe) was built in the early 1970s and is currently in a decommissioned state. The structure at present is under surveillance and monitoring. In the year 2000, a field investigation was conducted as part of a condition assessment and corrosion was detected in some of the grouted post-tension cable strands. However, no further work was done at that time to determine the cause, nature, impact and extent of the corrosion. An investigation of the Gentilly-1 containment building is currently underway to assess the condition of grouted post-tensioning cables and reinforced concrete. At two sel

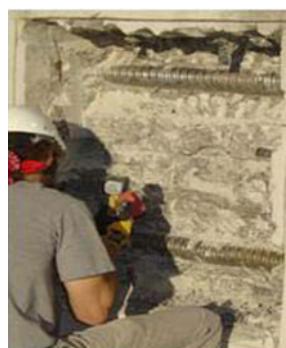
**Figure 5.** Concrete removed to expose the PT cable ducts.

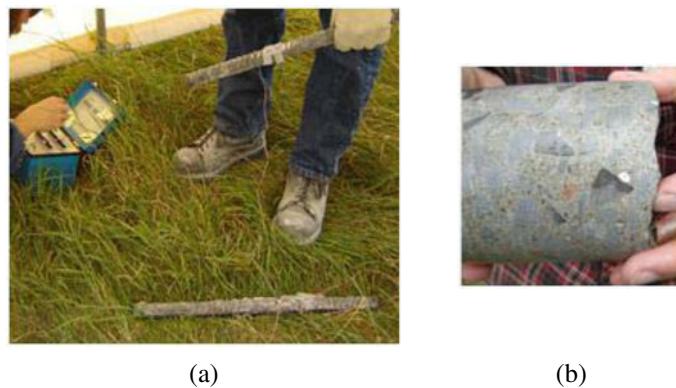
**Figure 6.** (a) Reinforcement bars. (b) Concrete core.

Figure 6(b) shows a concrete core taken out of the perimeter wall. Changes in strain on the horizontal steel reinforcement bars were measured during removal from the wall.

The steel reinforcement bars in the CCB perimeter wall were found to be in very good condition with no evidence of corrosion. Strain measurements on the horizontal reinforcement bars during their removal

from the test areas showed that the reinforcement bars were under tension prior to being cut. The average stress on the reinforcement bars was approximately 89.6 MPa based on the results of laboratory elastic modulus testing on specimens recovered from the structure.

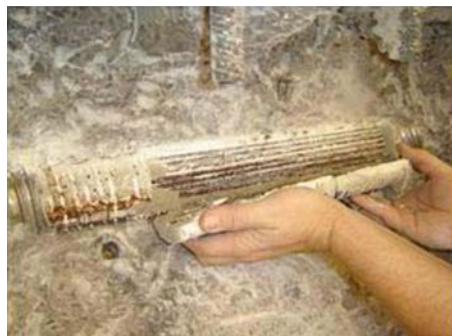
**Figure 7.** Cement grout being removed to expose cable strands.

The outer surface of the cable ducts were found to be in good condition. The inside surface of the ducts and the cement based grout were stained and contained corrosion products from the corroded PT cables. Figure 7 shows the cement based grout being removed to expose the cable strands.

The cable strands showed corrosion ranging from minor surface staining to widespread flaking and pitting. The severity of the corrosion generally increased towards the lower section in the cable. Several exposed cable strands (total of 32 cable strands) were visually examined; numbered and selected areas were cleaned and polished for installation of bonded foil strain gauges (see Figure 8). Reinforcement bars were also fitted with the strain gauges. Strain gauge readings were taken before and after cutting and removing the PT cable stands and reinforcement bars obtain the residual stresses in the strands and bars.

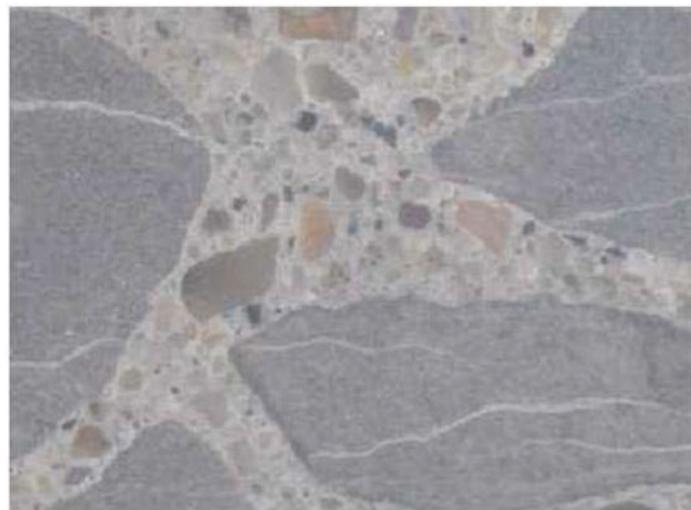
Petrographic examination revealed cracking (crack size was not measured but it seems to be micro cracking) of concrete through coarse aggregate and continuing through the concrete mortar, as shown in

**Figure 9.** Image showing micro-cracks in concrete.

Figure 9. The crack planes are all oriented parallel to the outer surface of the CCB. The probable cause of the cracking has yet to be confirmed; however, based on knowledge of the geology of aggregate sources in the areas near Gentilly, Quebec, alkali aggregate reaction (AAR), alkali silica reaction (ASR) or alkali carbonate reaction (ACR) are suspected. The material filling the cracks was identified optically under microscopic examination as silica gel, consistent with Alkali Aggregate Reaction (AAR).

The apparent lack of detrimental effects, due to the cracking observed in concrete, on the mechanical and physical properties such as compressive strength and resistance to chloride permeability may be due to the orientation of the cracks. The cracks were perpendicular to the axis of orientation for the RCP and compressive strength tests. No apparent concrete surface cracking on the CCB wall could be due to the confining effect of the PT system. Further research is required to understand the impact of AAR on concrete durability.

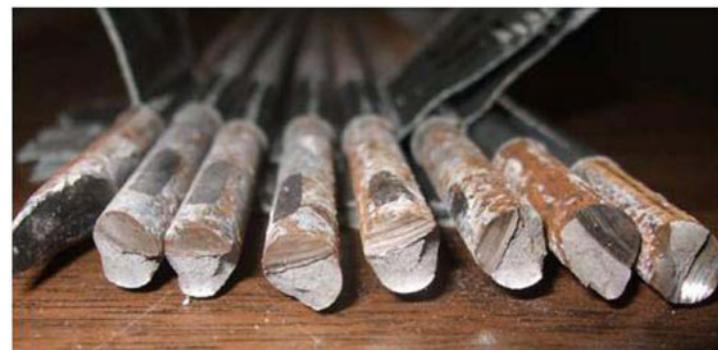
Figure 10 shows the strand ends after removal from the structure. It can be seen that the strands failed when approximately 50% of the cross section was severed during removal from the wall. Some necking took place in the specimen while being tested to failure in the laboratory. Figure 11 shows the necking of strands during destructive testing while Figure 12 shows the fracture surface that was typical of very strong steel.

**Figure 10.** Cable strands cut ends.

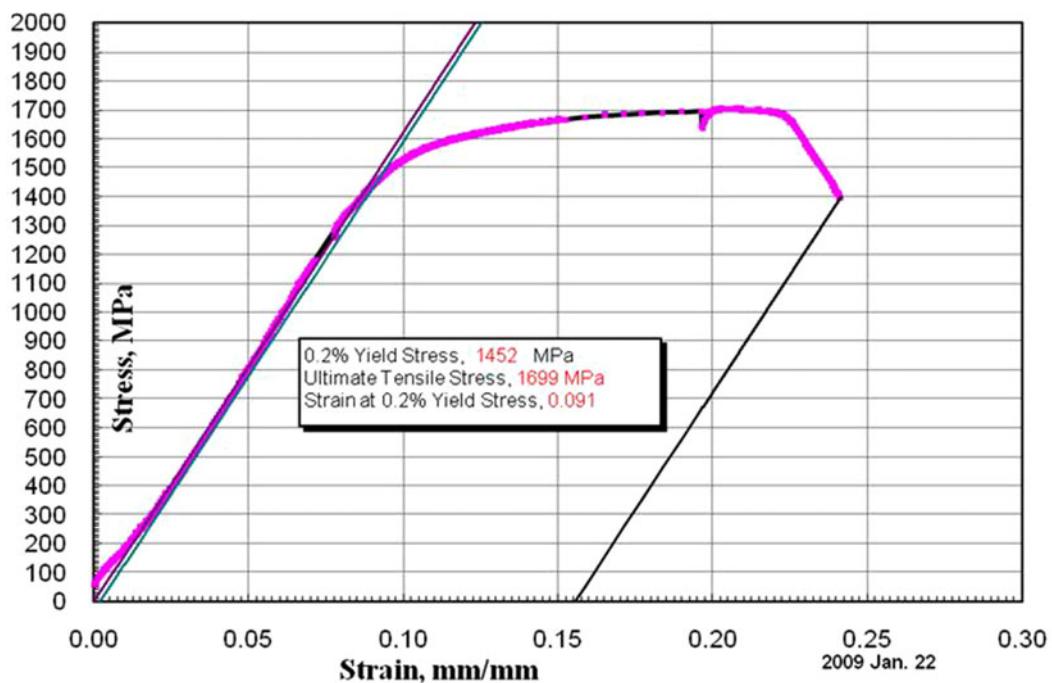
Figure 13 shows the tensile testing machine that was used for the laboratory destructive testing of the cable strands. Three strand specimens were tested and an average yield stress of 1450 MPa and an ultimate tensile stress (UTS) of 1690 MPa were obtained. The stress-strain diagram is shown in Figure 14. The yield and UTS compared well with the design values.

**Figure 14.** Stress/strain curve for PT strands tested to failure.
