Vulnerability analysis of a pressurized aluminum composite vessel against hypervelocity impacts

Pierre-Louis Hereil^a, Fabien Plassard, and Jérôme Mespoulet

THIOT INGENIERIE, Route Nationale, 46130 Puybrun, France

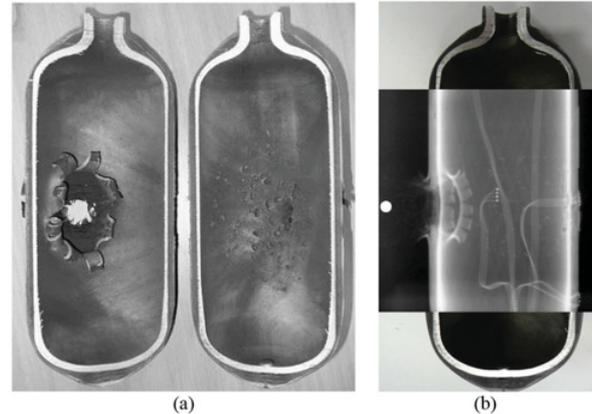
Figure 3. Test #HE0183: (a) Recovered vessel cut in two parts – Left: impact side – Right: rear side (b) Xray radiography at 41 μs after impact.

The first test #HE0183 was performed at an impact velocity of 4334 m/s and an internal pressure of 1 bar in the vessel. The measurement location of VH optical head is not in the axis of the impact but has been moved downward by 20 mm. The recovered vessel was cut in two parts in order to observe the impact zone and the back side of the internal aluminum liner (Fig. 3a).

The corresponding photograph shows the petaling shape of the impact area and the highly damaged

composite around the impact hole. The back side is characterized by many craters done by the debris cloud.

The radiography obtained at 41 μs after the impact, is depicted in Fig. 3b with superposition of a half portion of the initial vessel. This picture shows the shapes of the retrojet, of the impact crater and of the debris cloud. The white line corresponds to others measurements (strains gauges) not included in this paper. The shape of the projectile has been added on this picture (white circle on the left of the radiography).

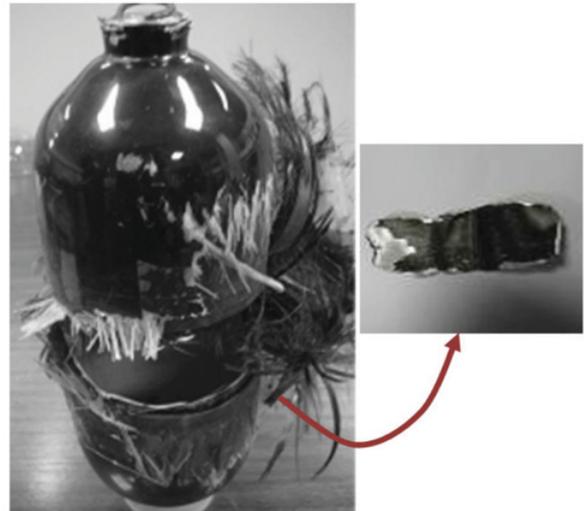
The second test #HE0184 was performed at an impact velocity of 4425 m/s and an internal N₂ pressure of 200 bar in the vessel. The recovered vessel (Fig. 5) is not fully failed but a large portion has been removed. The dimension of this portion corresponds to the impact hole: its width is the same as the diameter of the impact hole and its length is a half diameter of the vessel. The composite is fully damaged in this portion. Observations of the internal liner of this recovered vessel show no impact or crater specifically at the rear side.

Figure 5. Test #HE0184 (N₂ pressure of 200 bar): recovered vessel.

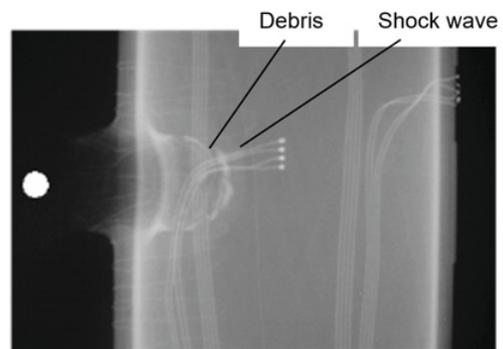
The radiography obtained at 15 μs after the impact (Fig. 6) shows the shapes of the retrojet, of the impact crater and of the debris cloud. The front wave which is visible forward to the debris cloud, is interpreted as the shock wave transmitted in the pressurized gas.

Figure 6. Test #HE0184 (N₂ pressure of 200 bar): Xray radiography at 15 μs after impact.

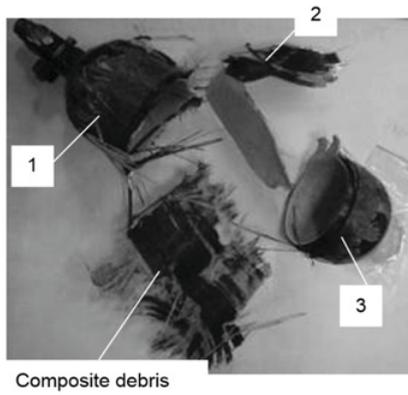
Figure 8. Test #HE0187 (N_2 pressure of 250 bar): recovered vessel.

The tested vessels (Fig. 8 and Fig. 9) are recovered in three and four parts:

- a bottom part,
- a top part,
- a central part (one piece for #HE0187, two pieces for #HE0188).

The external composite layers are highly damaged especially in the central area where they are fully broken. Inspection of the internal face of the aluminium liner reveals no craters and no trace of impact specifically on the rear side.

Failure mode is directly dependent of the composite stacking sequence. The penetration of the aluminum sphere leads to the rupture of the composite fibers. The confining stress induced by these overwrapped fibers is then released in this circumferential portion which results in the rupture of the aluminum liner at this same location.

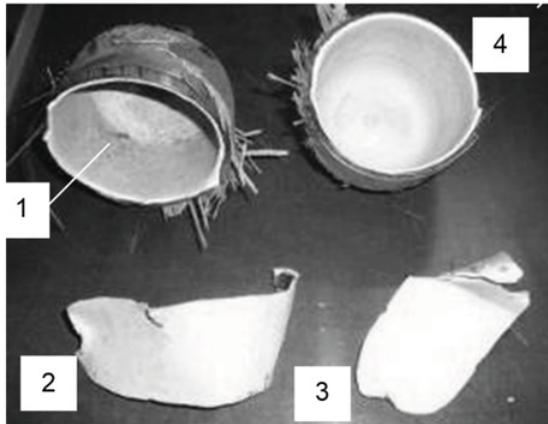
Figure 9. Test #HE0188 (N_2 pressure of 300 bar): recovered vessel.

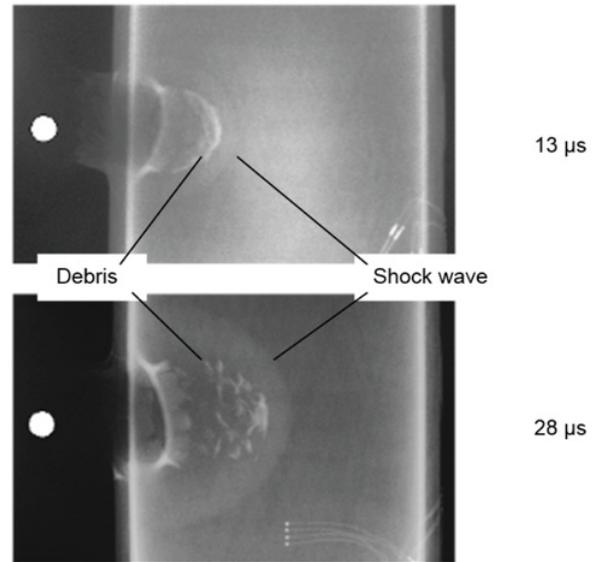
Radiographies obtained at $13 \mu s$ and $28 \mu s$ after the impact (Fig. 10 and Fig. 11) shows (from the left to the right) the retrojet near the impact zone, the shape of the impact crater, the debris cloud and the shock wave in the pressurized nitrogen. Due to the tilted configuration of the Xray stations, the shape of these different points seems more asymmetric than in the two previous shots.

Figure 10. Test #HE0187 (N_2 pressure of 250 bar): Xrays radiographies at $13 \mu s$ and $28 \mu s$ after impact.

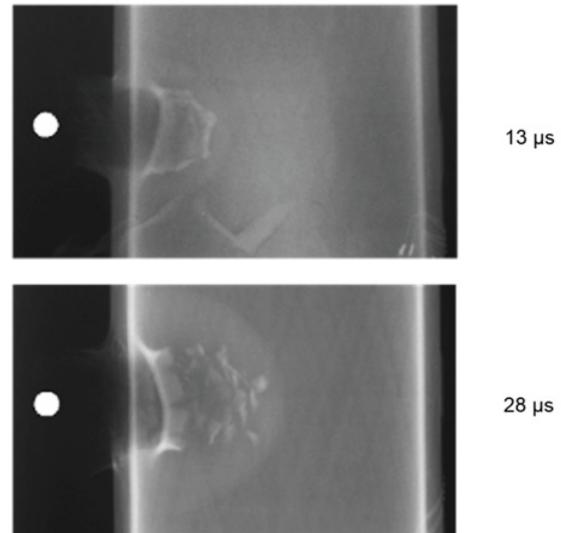
Figure 11. Test #HE0188 (N_2 pressure of 300 bar): Xrays radiographies at $13 \mu s$ and $28 \mu s$ after impact.
