# Fiber Reinforced Cement Mortars Degradation after their Exposure to Fire Conditions

N.D. Nikoloutsopoulos , A.B. Sotiropoulou and Z.G. Pandermarakis<sup>a</sup>

Department of Civil and Structural Engineering Technology Teachers  
School of Pedagogical and Technological Education (ASPETE)  
Irene Train Station – Athens – Greece

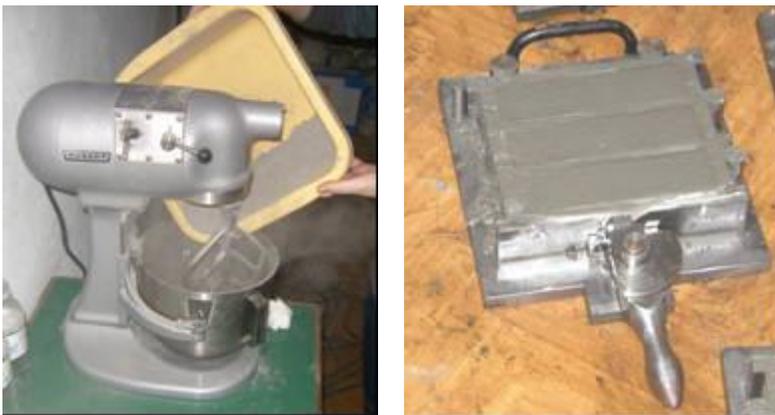
**Fig. 1a,b.** Mixer and standard mortar moulds.

High strength cement of I52.5 type was used. Marble aggregates up to 4mm size were added with cement to aggregate proportion be at 1/3. The attained water to cement ratio was 0.51 and the volume percentage of the added short random distributed short fibres was 0,26% for the glass (GL) reinforced specimens and the same for the polypropylene (PP). Specimens were prepared in suitable standard mortars moulds with dimensions of 16cmx4cmx4cm (fig.1). After their compaction in moulds they left for 28 days in a water tank and then at room conditions for another 28 days in order to equilibrate.

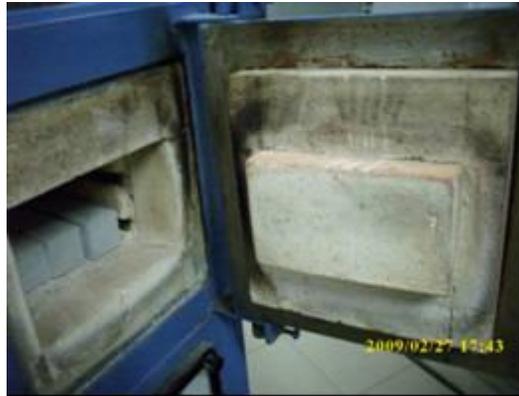
**Fig. 2.** The high temperature oven.

The specimens after their hardening period, placed in a high temperature oven (fig.2) and they left to a wide range of temperatures for 10, 30, 60 and 120min. During the heating period the heating

rate was kept at 30°C/min for low temperatures up to 400°C and at 2°C/min for higher temperature levels. During cooling period the rate was kept at 20°C/min.

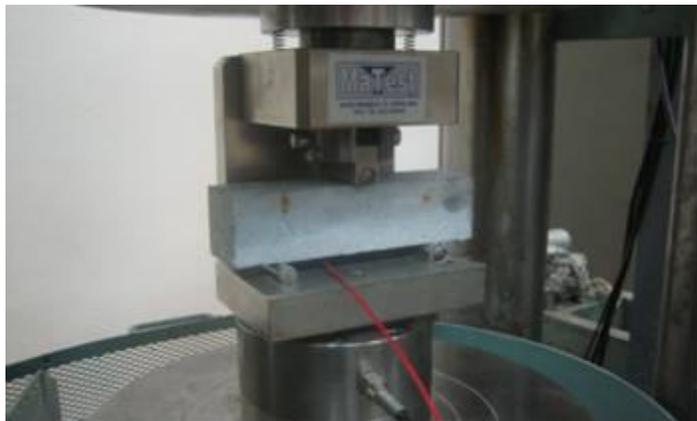
**Fig. 3.** Bending test arrangement.

After a day rest, specimens were tested by three point bending (fig.3 and 4). The load was measured by load cell, whereas strain was measured by suitable attached strain gauges at the bottom tensile specimen layer. High temperature exposed specimens were tested also to compression test, and were examined by ultrasonic heads and for density changes.

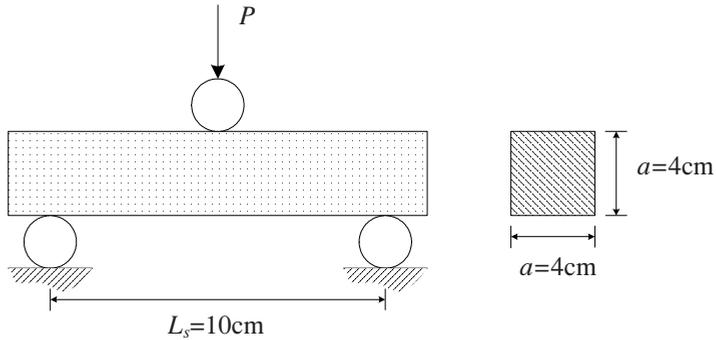
Fig. 4. The characteristic lengths of standard bending apparatus of mortars.

. Bending strength was estimated by the known bending rule, suitably modified for our case of standard mortar specimens and apparatus:

$$\sigma_b = \frac{15P_{\max}L_s}{a^3} \quad (1)$$

where bending strength  $\sigma_b$  is giving in (MPa), the load  $P_{\max}$  is giving in (kN) and the support length  $L_s$  and side  $a$  of the square section of specimen in (cm).

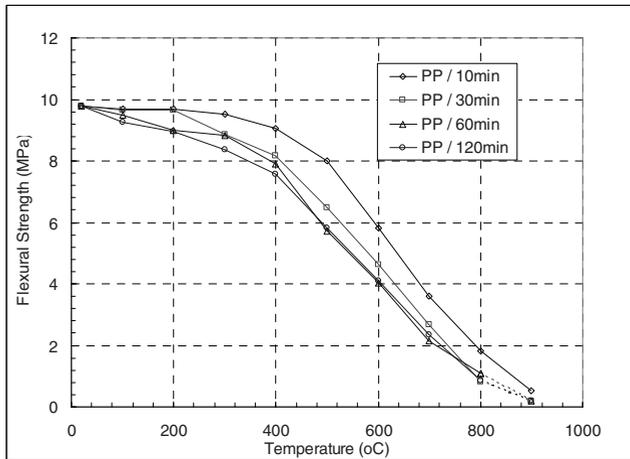
Fig. 5. Flexural strength via temperature and time exposure for PP fibre reinforced mortar.

At fig.5 and 6 we show the changes of bending strength of polypropylene fibre reinforced cement based mortar and of glass fibre respectively

Exactly, similar results were obtained for compression strength, flexural and compression modulus, densities and ultrasonic velocities. From these, we can see that due to the fire exposure, three distinct stages are appeared. At the first (that can be specified by temperatures up to 300°C), the mechanical response of cement composites appear small variations that depend basically on the loss of physical bounded water and the curing acceleration. In each case at the end of this stage a strength loss of about 10% of initial fiber reinforced mortar is appeared. At the next stage from 300°C up to 800°C a progressive diminishing of strength is happened due to the dehydrations of calcium hydroxide. The decomposition of  $\text{Ca}(\text{OH})_2$  that accelerates at the range of 400 to 500°C leads gradually to serious

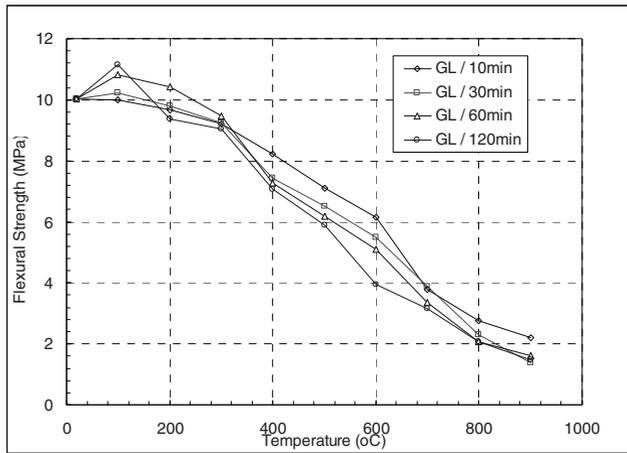
**Fig. 6.** Flexural strength via temperature and time exposure for glass (GL) fibre reinforced mortar.

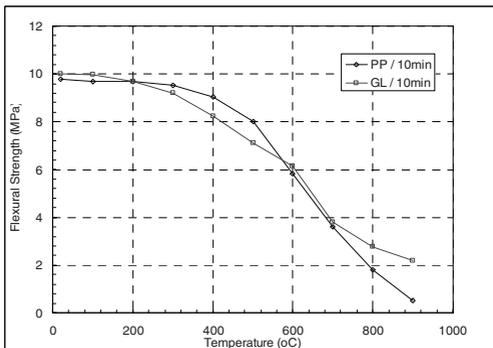
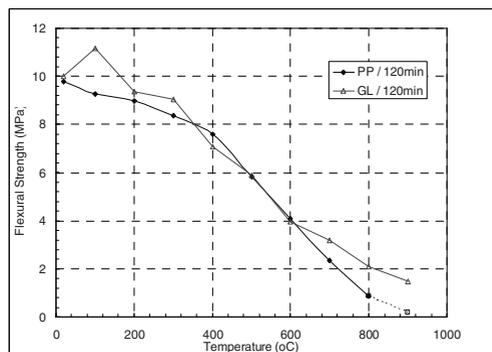
**Fig. 7a,b.** The relative strength variation of PP and GL fibre reinforced mortars for 10 and 120 min time duration of high temperature exposure.

Finally, at the third stage a general destruction of mortar is appeared due to the decomposition of calcium carbonate, the main constituent of marble aggregates. We can see that the duration of time exposure leads to a higher degradation of mortar but with a lower rate. As we can see from fig.7a and b, the glass fiber reinforced mortars appear a systematically higher strength than that of polypropylene fiber reinforced mortars mainly due to the stiffer response of glass fibers.

At the range of 300 to 500°C a reversion of their strength is appeared. This can be attributed to the fact that at the temperature level of 160°C the PP fibers are melted, whereas at the temperature of 590°C are burned and this can be the reason for the enhanced strength of PP mortars in the above narrow region. At the temperature level of about 800°C the glass fibers are melted resulting to a higher consistency of the degraded cement matrix.

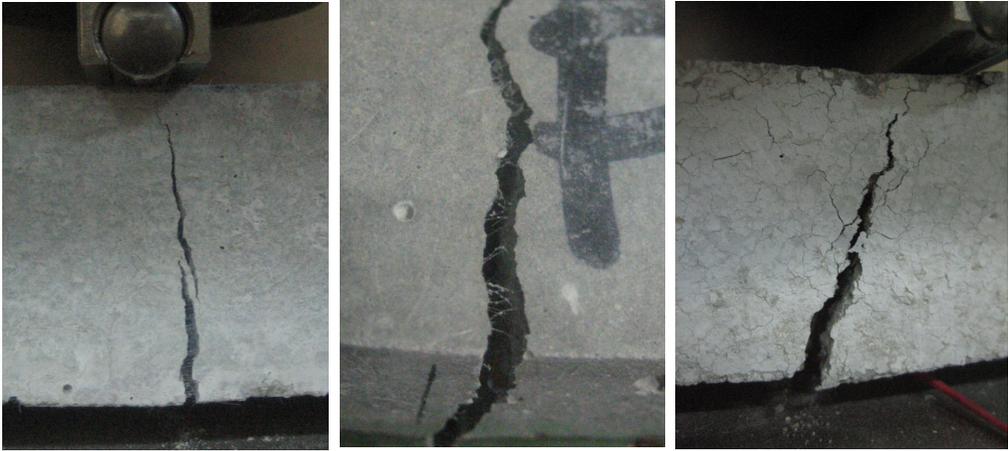
**Fig. 8a,b,c.** Specimens cracking during bending loading.

strength (fig.8). At left of fig.8, a PP fibre reinforced mortar specimen burned at 300°C for 10min, whereas at right the same mortar composite specimen burned at 900°C for the same time. At the middle figure we can see the pull-out effect of PP fibres during tensile fracture of bending specimens.

In all cases high thermal stresses due to different thermal coefficients and thermal gradient are appeared. These thermal stresses lead to an enhanced crack formation in specimens and so to a lesser
