Experimental research on the penetration of tungsten-fiber/metallic-glass matrix composite material bullet into steel target

Abstract. In the present paper, the penetration experiments of tungsten-fiber/metallic-glass matrix composite material bullets into 45# steel targets are conducted by employing H25 artillery. In which, an experimental technique of sub-caliber penetration is constructed. The quasi static and dynamic behaviours of tungsten-fiber/metallic-glass matrix composite material are also experimental investigated. The self-sharpening phenomenon of composite material is observed. Integrated with metallographic analysis, the failure modes of tungsten-fiber/metallic-glass matrix composite material are identified systemically and compared with the quasi-static and dynamic material tests. It includes four failure modes, i.e., shear fracture of tungsten fiber, brittle fracture of tungsten fiber and shear fracture of metallic glass matrix as well as melting of tungsten fiber and metallic glass matrix. Comparatively, three failure mechanisms of tungsten fiber in the bullet nose are also identified, i.e., shear fracture, splitting fracture and bending or/and buckling. Finally, t

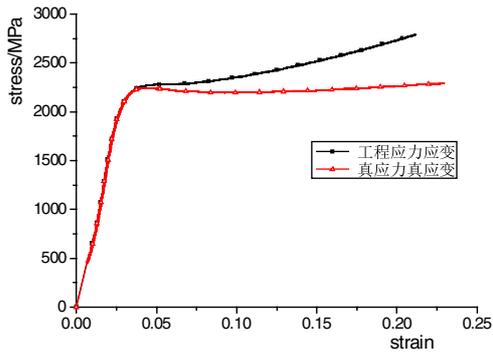
Fig. 1. Experimental results of quasi-static compression (a) stress-strain curve and (b) final deformation of specimen.

The loading rate of quasi-static material test is 0.2 mm/min and its strain rate is $8.3 \times 10^{-4} \text{ s}^{-1}$. Figure 1(a) shows the stress-strain curves and the flow stress is about 2200 MPa . Some perfoliate cracks along the longitudinal direction are observed in the lateral side of the post-test specimens, as shown in figure 1(b). The impact velocity of SHPB tests vary between 11.7 m/s and 16.7 m/s . Figure 2 shows the SHPB stress waves and dynamic stress-strain curve, respectively, at the loading rate of 12.3 m/s . Figure 3 shows the final deformation and fracture of specimens under different loading rates, and distinct cracking and destruction are observed.

the sharpening direction of bullet. Only a little tungsten-fibers produce splitting fracture in figure 16 and the crack develop along the fiber distribution, which is similar to the cases of figure 1(b) and figure 3 observed in quasi-static and dynamic material test, respectively.

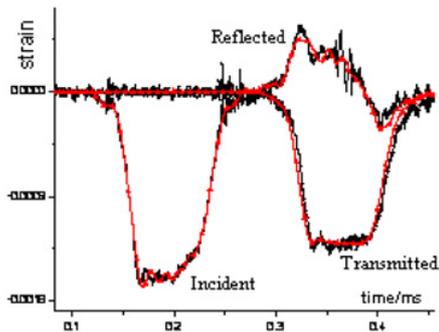
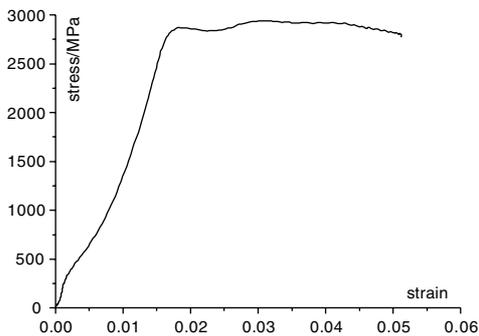
Fig. 2. Stress waves of SHPB and corresponding dynamic stress-strain curve (a) stress waves and (b) dynamic stress-strain curve.

the strain rate. Even at strain rate of 740 s^{-1} , the dynamic flow stress is larger than 30% the quasi-static one. No hardening effect exists in the plastic flow stage under

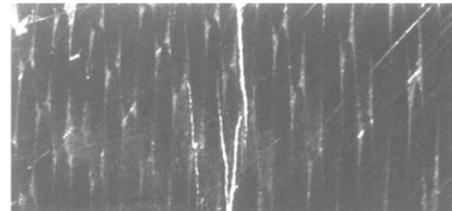
Fig. 4. Splitting and fracture of tungsten fibers in the specimen after SHPB experiment.

either quasi-static or dynamic loading. In macroscopic observation, the destruction pattern of SHPB specimen is likely as axial splitting. Comparatively, the microscopic failure includes the isolation of tungsten fiber and metallic glass matrix, splitting fracture of tungsten fiber, and so on.

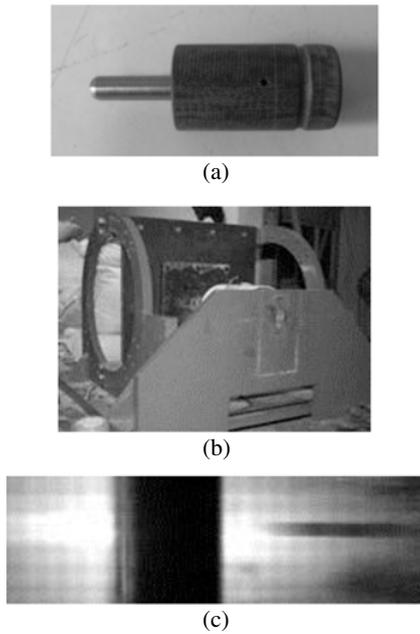
Fig. 5. Experimental technique of sub-caliber penetration (a) sabot and bullet, (b) target frame and (c) high-speed photograph.

Since the diameter of bullet is quite smaller than that of the H25 artillery, an experimental sub-caliber technique of APM2 bullet launched by the H25 artillery is employed in the present paper. A bakelite sabot is used to fit the larger diameter of artillery for firing a smaller bullet, which mass is much smaller than the bullet mass. In order to ensure a bullet impacts in good appearance, a bakelite rod is stick to the rear bottom of the bullet to move its centroid forward. The length of the bakelite rod is 15 mm and its mass is about 0.8 g , while the bullet mass is 7.5 g . Two impediment plates are mounted before the target plate to separate the sabot and stop the sabot fragments, respectively.

The experimental installation is shown in figure 5(a)–(b), and figure 5(c) shows the high-speed photograph of penetration. It is found that the bullet impacts 45# steel target in good appearance and no any yaw or deviation occurs. Meanwhile, the bullet completely separates from the bakelite sabot before it impacting the target.

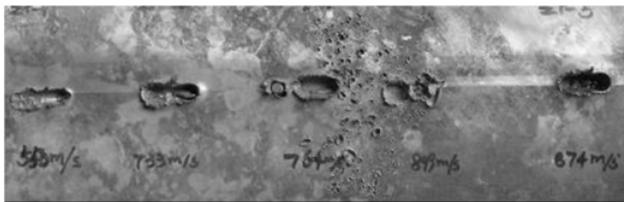
Fig. 6. 45# steel target after penetration with different impact velocities.

The post-test target is shown in figure 6. In general, for most tests except No. 4 launch, the target surface around the crater is smooth, which indicate that the impediment plates are capable to stop the sabot fragments. However, at smaller impact velocities, e.g., $V = 550$ m/s and 733 m/s, ricochet takes place and no effective penetration. Only under higher impact velocity, the bullets penetrate into the steel target effectively.

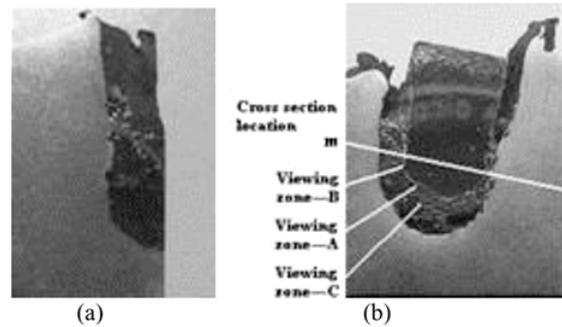
Fig. 7. Macroscopically longitudinal section of 45# steel target after penetration (a) $V = 874$ m/s and (b) $V = 764$ m/s.

Figure 7 shows the macroscopically longitudinal section of 45# steel target after penetration in cases of $V = 874$ m/s and $V = 764$ m/s. The nose diameter of residual composite material bullet has no any obvious change. In particular, in case of $V = 874$ m/s, the bullet completely eroded, and it is unable to identify the original microscopic

structure of tungsten fiber and metallic-glass matrix. There left a trace of reversal flowing of thawy bullet material along the ballistic path. In case of $V = 764$ m/s, the residual bullet includes two parts, i.e., eroding part and no deforming part. Also the trace of reversal flowing of thawy bullet material in the penetration hole is observed. The following analysis will mainly focus on the case of $V = 764$ m/s, to discuss the failure of bullet material under higher velocity impacting. The line mn in figure 7(b) stands for the cross section location of the present analysis, and viewing zones A, B and C are the corresponding location of analytical longitudinal section, respectively.

As shown in figure 7(b), after penetrating into #45 steel plates, the nose shape of the tungsten-fiber/metallic-glass matrix composite material bullet deformed distinctly. The original hemi-spherical nose became as sharp nose due to the erosion, i.e., self-sharpening occurs. The diameter of ballistic hole in target always kept constant but the hole wall is quite rough and have the trace of high-heat melting, friction and mass consumption. In the mean time, the self-sharpening of the bullet nose may cause the asymmetric resistant force acting on the bullet nose and therefore the ballistic locus of bullet deviated. The tungsten fibers, which located in the eroding part of bullet nose, shear fracture or/and bend along the direction with 60° angle to the bullet axis. The tungsten fibers fall off from metallic-glass matrix after shear fracture. The shearing surfaces compose a sharp nose and it makes the bullet self-sharpening continually. By the way, the broken tungsten fibers stick on the lateral wall of ballistic hole of steel plate, and it seems as reversal flowing along the ballistic path.

We will conduct metallographic analyses on the transverse and longitudinal sections of bullet nose, to identify the different modes of self-sharpening shear failure of tungsten-fiber/metallic-glass matrix composite material. All the selected zones and the corresponding illustrations are shown in figure 7(b).

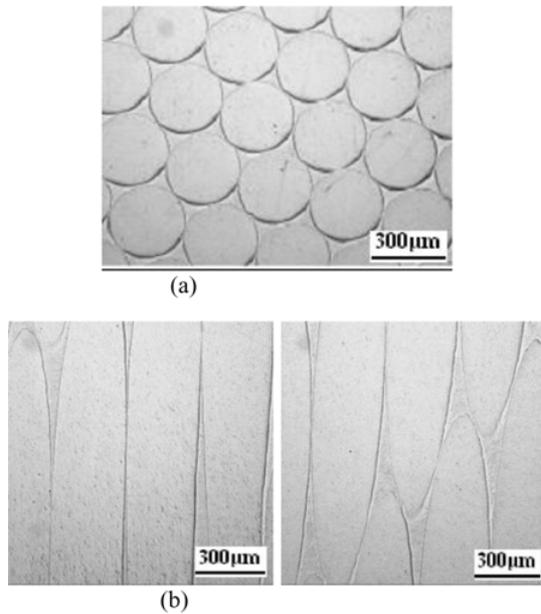
Fig. 8. Metallographic graphs of transverse and longitudinal sections of initial composite material penetrator (a) transverse section and (b) longitudinal section.

Figure 8 are the metallographic graphs of transverse and longitudinal sections of initial composite material bullets, respectively. Obviously, in the transverse section, all the tungsten fibers arrange in order and proximately integrate with the metallic-glass matrix. The end section of tungsten-fiber is a standard circular shape. In the longitudinal section, the tungsten fiber direction agree with the bullet axis and the fibers look like slender ellipses, which since the longitudinal section crosses the bullet axis with a certain angle.

With compared to figure 8(a), i.e., the metallographic graphs of the prototype bullet, at least 4 kinds of self-

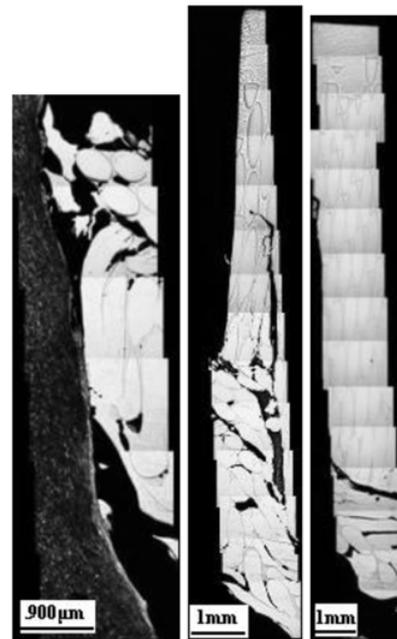
Fig. 9. Metallographic graphs of left longitudinal section of bullet after penetration.

Figure 9 shows the metallographic graphs of left longitudinal section of bullet after penetration at velocity of $V = 764$ m/s. The deformation and destruction of composite material bullet almost localizes in the margin of nose and its vicinity. In the zone of non-erosion and undeformation

of bullet nose, tungsten fibers have no obvious plastic deformation, and its arranging direction is still parallel to the bullet axis. Meanwhile, metallic-glass matrix also has no any distinct damage. It indicates that the tungsten fiber and metallic-glass matrix in this zone are same as the initial material. Some melted metallic-glass matrix and tungsten fibers re-freeze and reserve in the ballistic hole of steel plate. The eroding material cumulates before the bullet nose and behaves as reversal flowing along the ballistic path. Melted tungsten fibers distribute without any order. It deduced that a large amount of heat come into being when the bullet penetrating into steel plate at higher velocity, which causes the metallic-glass matrix material soften and even molten. In the other hand, non-eroding bullet nose will reserve a clear outline contour with a certain acute angle, and all the tungsten fibers distribute in the same direction. The nose shape of the bullet displays a distinct characteristic of self-sharpen. It can be observed that splitting fracture exists in the part of non-eroding bullet material. Meanwhile, a remarkable disassociate gap occurs between the eroding part and non-eroding part.

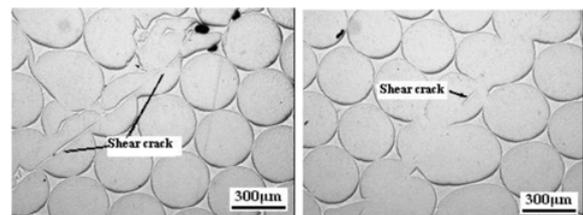
Fig. 10. Self-sharpening shear failure of bullet, Mode I: shear fracture of tungsten fibers.

Mode I: shear fracture of tungsten fibers. As shown in figure 10, the shear fracture will only arise in a row of tungsten fibers. Just in that narrow localization zone, the tungsten fibers melted and slipped to produce dislocation. Comparatively, the tungsten fibers around the shear band keep as intact as before. Therein the failure and destruction of material localize in a very narrow zone. It belongs to a typical adiabatic shear.

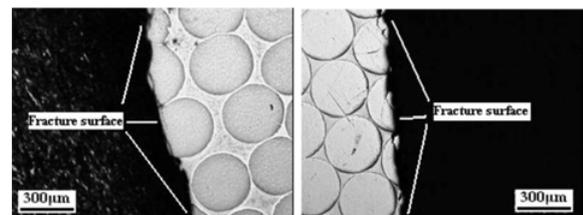
Fig. 11. Self-sharpening shear failure of bullet, Mode II: brittle fracture of tungsten fibers.

Mode II: brittle fracture of tungsten fibers. As shown in figure 11, it arise in the margin of bullet nose, accompanied with some fiber dreg. No any remarkable plastic deformation can be observed in the broken tungsten fiber. Similarly,

the nearby tungsten fibers keep as intact as before. It is caused by scrape between bullet and steel target during high speed impact.

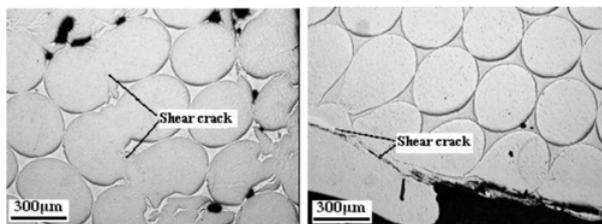
Fig. 12. Self-sharpening shear failure of bullet, Mode III: shear fracture of metallic glass matrix.

Mode III: shear of metallic glass matrix. As shown in figure 12, shear fracture occur in the metallic glass matrix, and cause the ambient tungsten fibers thermoplastic deform and flow along the shear direction. The metallic glass matrix detach from the tungsten fibers. All the deformation and failure are localized in a narrow zone.

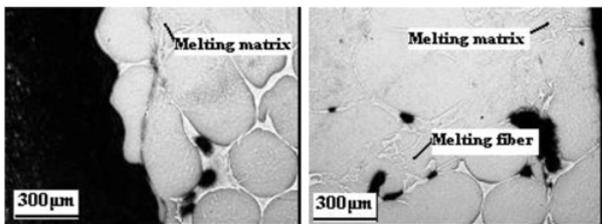
Fig. 13. Self-sharpening shear failure of bullet, Mode IV: melting of tungsten fibers and metallic glass matrix.

Mode IV: melting of tungsten fibers and metallic glass matrix. As shown in figure 13, a large amount of heat arise in the high-speed penetration into the 45# steel plate of tungsten-fiber/metallic-glass matrix composite material bullets, which causes the metallic-glass matrix material and tungsten-fiber soften and even molten.

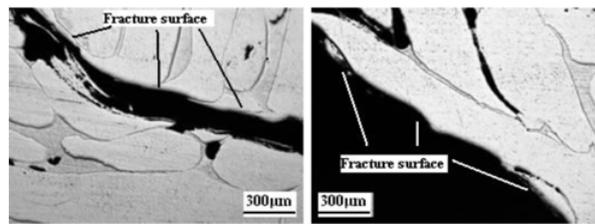
Fig. 15. Failure of tungsten fibers in the penetrator nose, mode I: shear fracture (Zone A).

We will discuss the interaction of the mentioned failure modes. Figure 15–16 redisplay shear fracture and brittle splitting fracture of tungsten fiber, respectively, while figure 17 shows the bending and buckling of tungsten fibers and it presents as a notable plastic hinge. In figure 15, shear fracture behaves as localization and it flows along

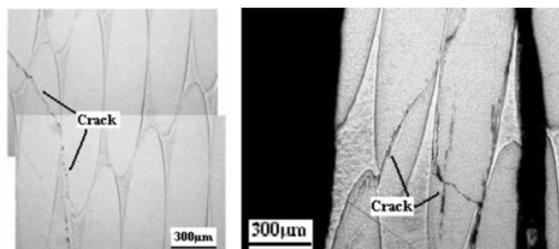
Fig. 16. Failure of tungsten fibers in the penetrator nose, mode 2: splitting fracture (Zone B).

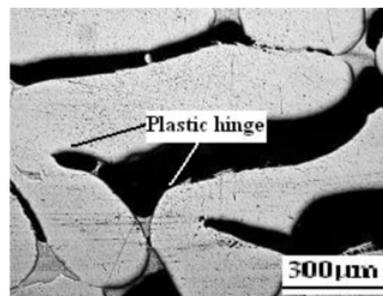
Fig. 17. Failure of tungsten fibers in the penetrator nose, mode 3: bending and buckling (Zone C).
