# Impact performance of specimens subjected to fatigue loading – experimental investigation

**Abstract.** The impact performance of reinforced concrete specimens subjected to fatigue loading has not been quantified properly yet. This topic is significant in the field of vehicle impact or similar applications. The paper aims to fill this gap by presenting the on-going experimental program. The paper presents outcomes of the experiments focused on the performance of RC beams subjected to drop-weight impact loading. The behaviour of the beams which were prior to the impact testing subjected to cyclic loading was compared to the behaviour of the beams which were not subjected to cyclic loading.

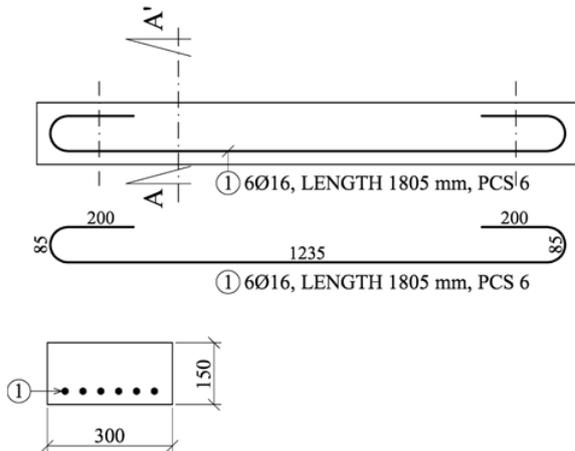
**Figure 1.** Reinforcement scheme of the specimens.**Table 2.** List of all specimen sets.

The specimens were designed as over-reinforced (6 ∅ 16 grade B500 reinforcing steel), thus a failure by compressive-zone crushing should occur and the fatigue failure of concrete (bending/shear) can be assumed during the cyclic loading. The scheme of specimen reinforcement can be seen in Fig. 1.

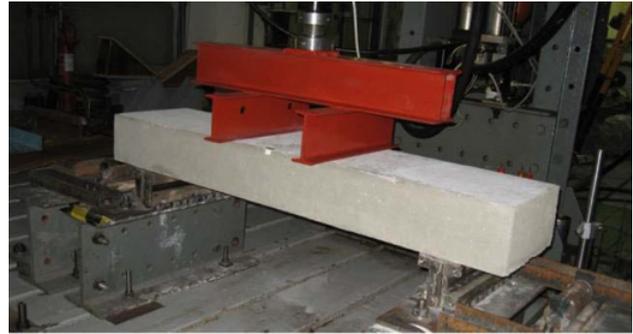
**Figure 2.** The arrangement of the fatigue testing.**Table 3.** Specification of the fatigue testing settings.

The arrangement of the cyclic loading is the four-point bending test with span length 1000 mm and overhangs with

Experiments are conducted in the Experimental Centre of Faculty of Civil Engineering, Czech Technical University in Prague. The arrangement of the fatigue testing can be seen in Fig. 2, for its parameters see Table 3.

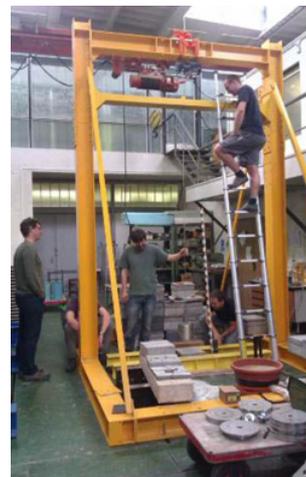
**Figure 3.** Steel frame and the scheme of the experiment.

For the impact loading, a braced steel frame (Fig. 3) carrying drop weight was built in the Experimental Centre of the CTU. Due to laboratory build-in crane, height of

the frame is limited to 4.1 m. Horizontal base of the construction is made of steel frame anchored to the floor of the laboratory. Vertical stability is provided by bracing diagonals. The burden is considered as a set of different weights to enable maximal variety of the drop-weight.

The tested concrete specimen is located in the biaxial centre of the horizontal frame. The sample is supported on two parallel sides by reinforced steel girders which were anchored to the floor. To ensure similar layout as in case of the cyclic loading two reinforcing bars were attached to the steel girders. This ensured the span length of 1000 mm and simple supported beam behaviour. The difference between the cyclic loading and impact loading is in the force position (four-point bending for cyclic loading and three-point bending for impact loading).

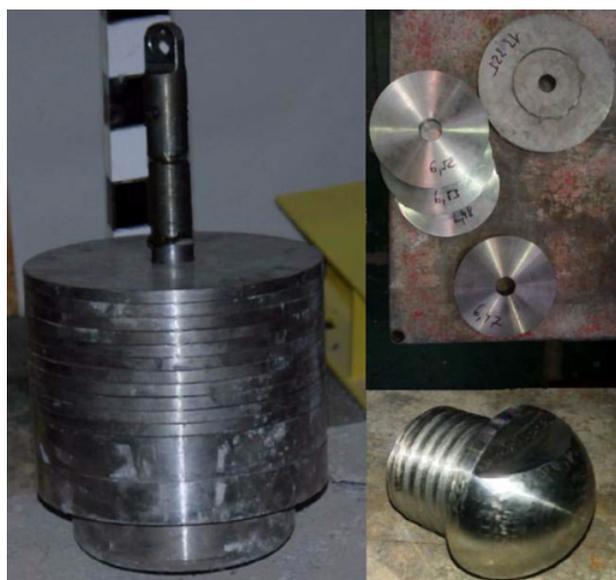
Figure 4. Steel burden, discs and hemispherical tip.

The steel burden used during the experiment consisted of a central pole and a main cylinder/hammer, which supports steel discs of different weights. The required weight was obtained by combination of the steel discs.

On the lower surface of the steel cylinder, a hemispherical tip ( $R = 20$  mm) is placed, which concentrates the applied impact loading into one exact point. The burden used for the testing weights 90 kg. The burden, discs and tip can be seen on Fig. 4.

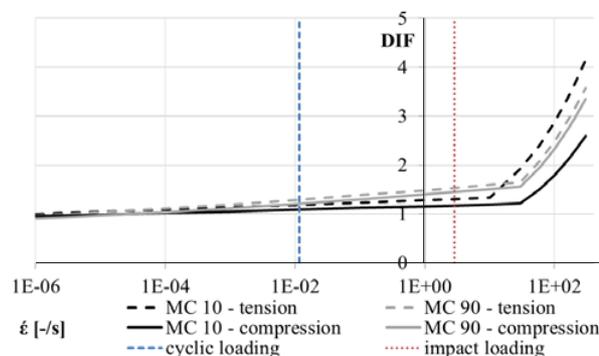
Figure 5. DIF according to MC90 [8] and MC10 [9].

The evaluated strain rates with corresponding values of DIF are listed in Table 4. The development of DIF as a function of different strain rates can be seen in Fig. 5. The results of the first run of tests are described further.

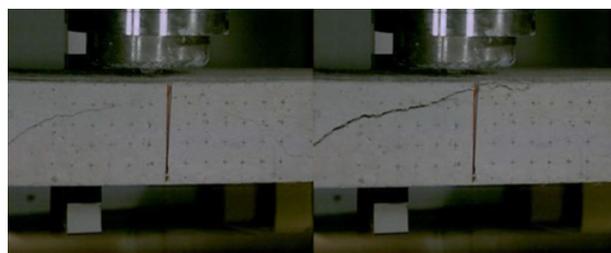
Figure 6. Two sample frames from the high-speed camera.

The decrease in instantaneous velocity within the impact together with the increase in deflections were chosen as a main factors for the evaluation of the specimens behaviour and resistance to impact loading. The experiment was recorded with high-speed camera with 10.000 fps. The video sequence was used for the evaluation of the behaviour. Two sample frames with time interval 1 ms can be seen in Fig. 6.

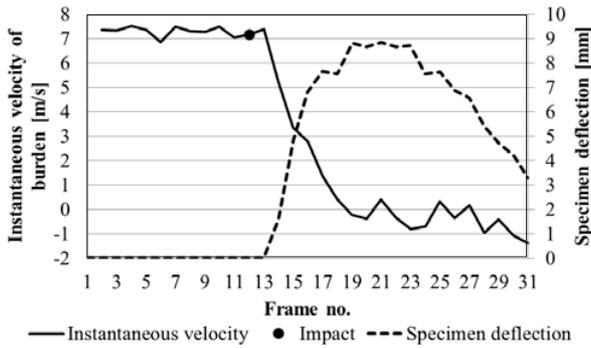
Figure 7. Development of burden velocity and specimen deflections during impact (specimen #1).

Results for the specimen #1, not exposed to cyclic loading, are in Fig. 7.

After the impact (frame 12) the steep decrease in velocity can be observed. The absorbed energy is reflected in deflection increase. The impact lasts about 8 ms (each frame corresponds to 1 ms). The shear cracks appeared similarly to the fatigue testing as can be seen on the Fig. 8.

From the results depicted in Figs. 7, 9 and 11 preliminary conclusions can be drawn. The comparison between the behaviour of all three tested specimen from the viewpoint of the velocity or deflections can be seen on the Figs. 13, 14 respectively. The Figures depict only the time interval after the impact. The impacts last cca 8, 12 and 14 ms respectively for the specimen #1, #2 and #3. The assumed ends of the impacts are marked with points.

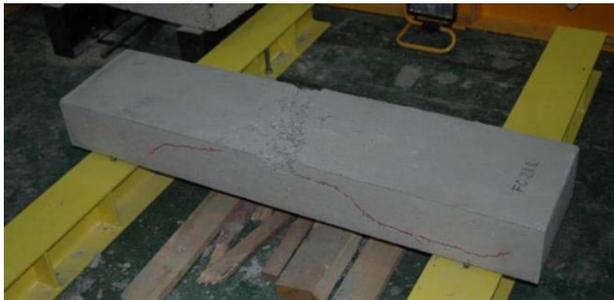
Figure 8. Condition of the specimen after impact (spec. #1).

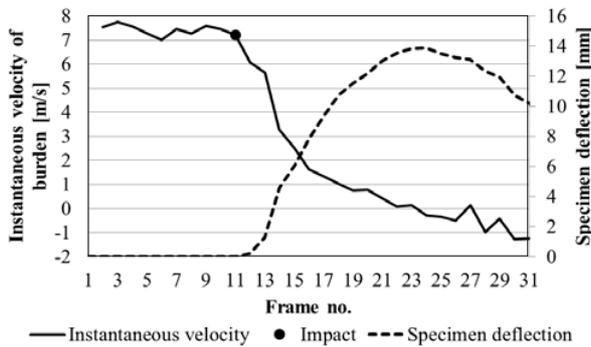
Figure 9. Development of burden velocity and specimen deflections during impact (specimen #2).

Results for the specimen #2, exposed to cyclic loading, are in Fig. 9. The decrease in velocity after the impact is slower than for the specimen #1. Shear cracks from the fatigue testing were opening, thus the energy was absorbed at slower rate, but with result of higher deflections. The impact lasts about 12 ms. In comparison of the specimen #1 and specimen #2 the increase in deflections in impact loading due to the damage caused by fatigue testing is up to 40%. Condition of the specimen #2 after the impact loading can be seen in Fig. 10.

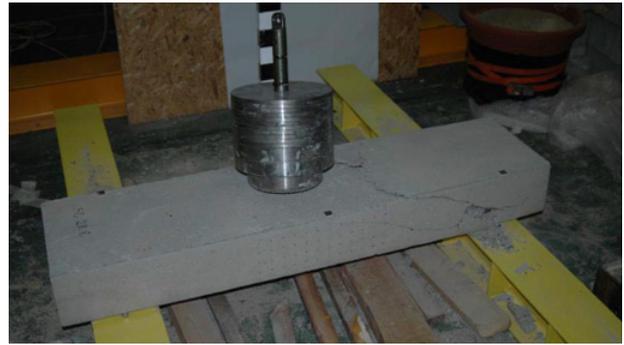
Figure 10. Condition of the specimen after impact (spec. #2).

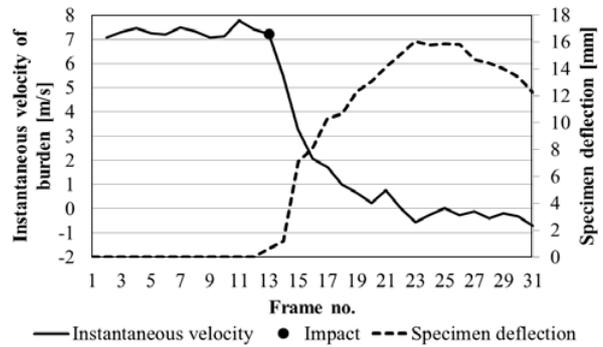
Figure 11. Development of burden velocity and specimen deflections during impact (specimen #3).

Results for the specimen #3, chemically deteriorated specimen exposed to cyclic loading, can be found in Fig. 11. The decrease in velocity after the impact is slower than for the specimen #1 and #2. Shear cracks from the fatigue testing were opening and the deteriorated layers of concrete crushed in contact with the burden. Duration

of the impact was about 14 ms. In comparison of the specimen #2 and specimen #3 the increase in deflections in impact loading due to the damage caused by chemical deterioration is up to 15%. When comparing the specimen #1 and #3 the increase in deflections due to the combined deterioration due to fatigue and aggressive environment is up to 60%. The specimen #3 after the impact loading is in Fig. 12.

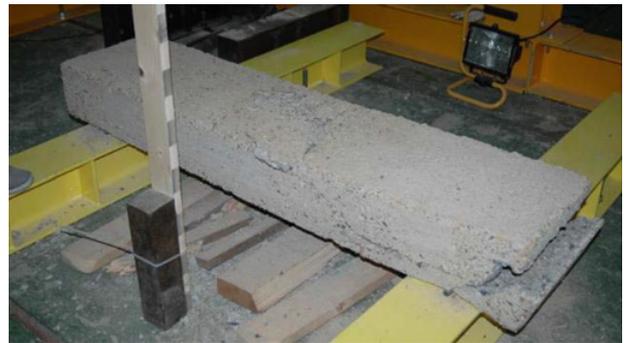
Figure 12. Condition of the specimen after impact (spec. #3).

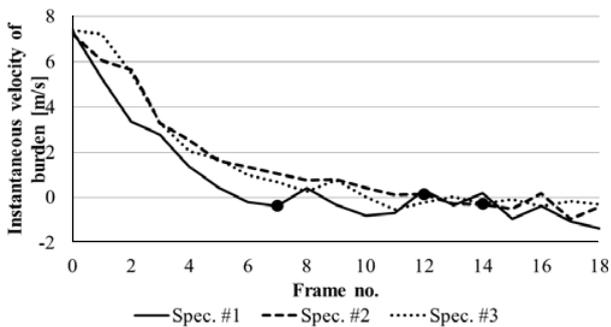
Figure 13. Comparison of the specimens in view of the velocity.

The differences in the decrease in the velocity of the specimens can be observed. The impact in case of

the specimen #1 last only 8 ms. After that the hammer rebounded and the velocity on the graph acquires negative values (movement against the direction of gravity). The impact interval of the specimens #2 and #3 last up to 75% longer (14 ms in case of specimen #3).

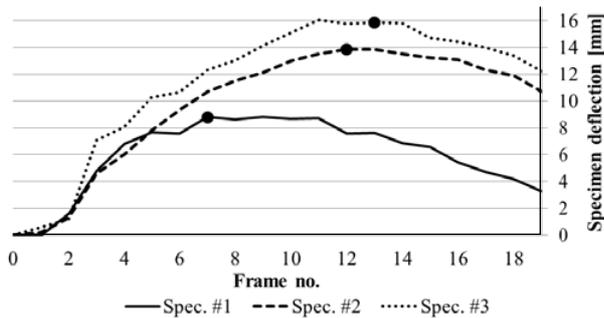
Figure 14. Comparison of the specimens in view of the velocity.

The comparison with respect to deflections corresponds to the velocity comparison. The deflection of the specimen #1 is significantly lower than in case of the other specimens.

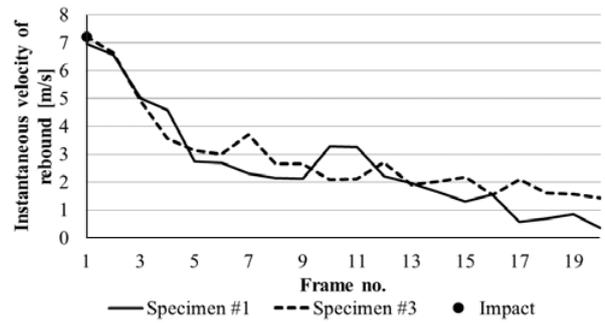
Figure 15. Results of the 2<sup>nd</sup> impact loading – inst. velocity.

Due to technical difficulties, the video sequencing used for the evaluation was not triggered at each time, thus the results for the 2<sup>nd</sup> and 3<sup>rd</sup> impact loading of the specimen #2 and 3<sup>rd</sup> impact loading for the specimen #1 are not evaluated. Comparison for the behaviour of the specimens #1 and #3 during the second impact loading can be seen on Figs. 15 (instantaneous burden velocity) and 16 (specimen deflections). The graphs take into account only the interval of the impact.

As can be observed on the Figs. 13 and 14 the behaviour after the first impact loading is similar for the both specimens. The decrease in the velocities is slightly lower in the case of the specimen #3 which corresponds with the higher cracks distribution in the specimen, thus lower rate of the energy absorption.

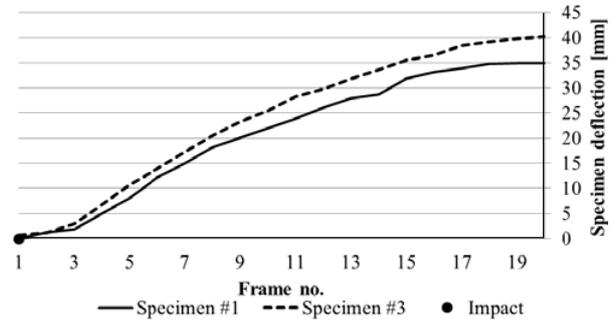
Figure 16. Results of the 2<sup>nd</sup> impact loading – spec. deflections.

In case of the deflections the pattern is the same for both specimens. This is mainly due to the fact, that the specimens are already severely damaged especially in the tensile zone, thus the magnitude of deflections is primarily affected by the steel reinforcement, which is the same in both specimens (6 × Ø16 B500B). The higher deflection

of the specimen #3 can be attributed to the coupled chemical and mechanical damage (due to the aggressive environment and cyclic loading) of the concrete matrix in compression.
