Energy efficiency and economic analysis of the thermomodernization of forest lodges in the Świętokrzyski National Park

Abstract. This paper analyses energy efficiency of thermomodernization project on the example of three forest lodges located in the Świętokrzyski National Park. Currently, one of the basic requirements posed for the buildings subjected to modernization is to reduce carbon dioxide emissions even above 80% in comparison with the original values. In order to fulfil such criteria, it is necessary to apply alternative solutions based on renewable energy sources. Due to limited budget, low cubic capacity and location of the buildings, solar collectors with storage tanks and biomass boilers provide a rational option. For such a case, the emissions of basic pollutants such as CO₂, SO_x, NO_x or particulates is obtained. The study also gives the results of calculations of payback time (SPBT) for the investment for exemplary forest lodge.

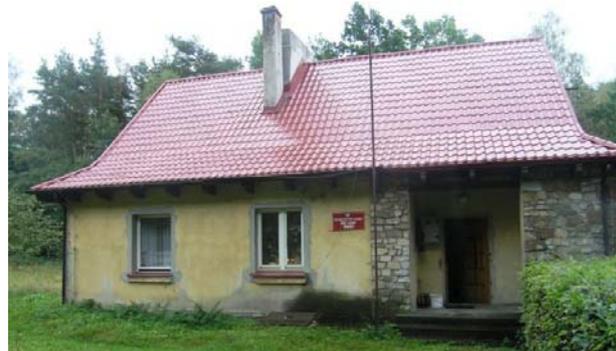
Because of the buildings location in the vicinity of deciduous trees, the area layout needed to be altered in such a way as to prevent further biological degradation of the walls that is observable in Figure 1. Biological corrosion was found on the surfaces of interior timber ceilings.

Fig. 1. A view of the western façade of Forest Lodge 2 after partial thermal upgrading (roof replacement), the photograph by Piotr Szafraniec, Świętokrzyski National Park.

Additionally, computations concerning thermal and moisture conditions, carried out acc. [15], demonstrated that the exterior wall in Forest Lodge 2 ($U = 0.733$ W/m²K, $R_c = 1.365$ W/(m²K)) was incorrectly designed with regard to avoiding mould growth. The effective value of the temperature coefficient of the building envelope element, $f_{Rsi} = 0.712$, was determined on the basis of the heat transfer coefficient U and the total thermal resistance of the element R_c . Steam condensation is observed in the months of the space heating season from November till March. February turned out to be a critical month as the temperature coefficient was $f_{Rsi,max} = 0.732$.

Additionally, thermal energy demand was established by means of computations [17]. For central heating system, especially in old buildings, it is difficult to unambiguously determine the demand value without earlier monitoring of the internal environment parameters [18]. The rooms are most often underheated, the design internal temperature values are not reached during the heating period, and moisture accumulations are found on the envelope elements (see Figs. 1 and 2).

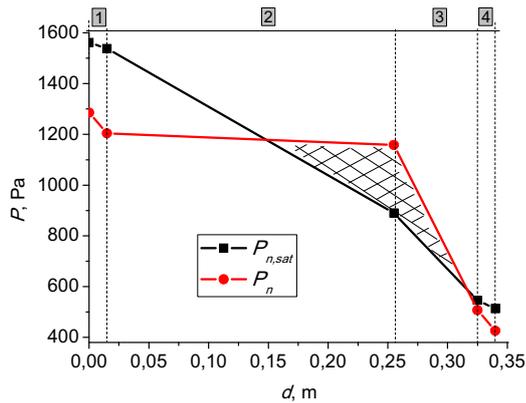
To avoid the accumulation of moisture, the building envelope element should be designed in such a way so that the condition $f_{Rsi} > f_{Rsi,max}$ could be satisfied. Figure 2 shows pressure distribution in the element of concern. It can be seen that in the second and third layers of the wall, the saturation pressure $P_{n,sat}$ takes on the values lower than steam partial pressure P_n , which results in precipitation.

Fig. 2. Graph of moisture condensation in the critical month in the exterior wall shown in Figure 1; 1-4 – the envelope components in succession: cement-lime plaster, hollow masonry unit, cement-bonded particle board, cement-lime plaster.

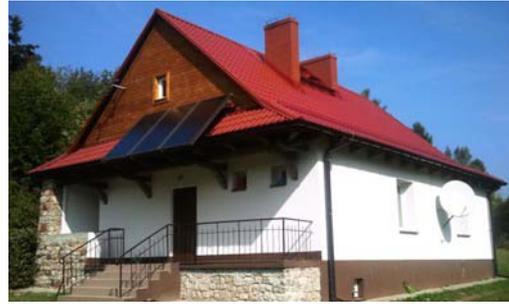
Figure 3 shows Forest Lodge 2 after thermal upgrading with solar collectors installed on the south side of the building. The building envelope elements were appropriately designed to avoid mould growth.

Fig. 3. A view of the eastern and southern façades of Forest Lodge 2 after thermal upgrading (solar collectors installed), the photograph by Piotr Szafraniec, Świętokrzyski National Park.

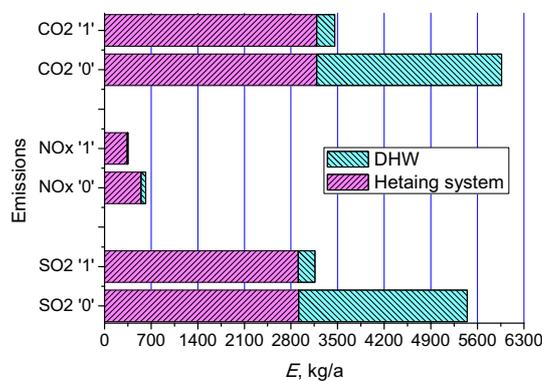
The computations of yearly amounts of harmful substances emitted into the atmosphere, including the most important ones, i.e. carbon emissions, together with the environmental effect for exemplary Forest Lodge 2 are shown in Figure 4.

Fig. 4. Environmental effect of thermal upgrading for exemplary Forest Lodge 2; '0' – before, '1' – after thermomodernization.

Multiplying the computed emissivities by the so-called toxicity index K , equivalent emissions for individual substances before (E_{r0}) and after (E_{r1}) thermal upgrading

are calculated. The environmental effect for equivalent emissions was determined from the dependence: $E = E_{r0} - E_{r1}$. The results are presented in Table 7.
