Analysis of spatial state of multistory building with ceiling without beams

Abstract. In this paper, we discuss a spatial work of construction structures under an influence of pulsating wind loads. There are examples of deformations those arise from incorrect arrangement of rigid structures. We consider the forms of oscillation of a frame building and show the result of their incorrect sequence. There are calculations in software and computer complex and their results are shown in the form of isofields of internal stress of enclosing structures. The results of calculations are compared with real deformations of structures. The work of a structure is considered on the example of an existing building.

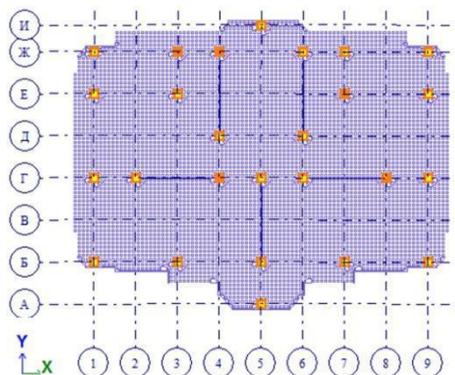
The geometric centre and the centre of mass are located between the axes "G" and "D", the stiffness elements forming the centre of stiffness in this direction located on the axis "G" (look at fig. 1).

Fig. 1. Horizontal projection of the design scheme of the structure.

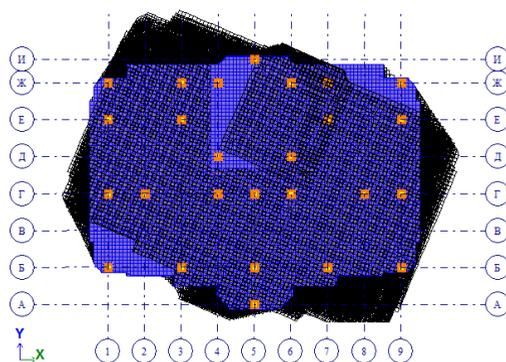
In accordance with SP 20.13330.2016 [4] the first two forms of oscillation – must be flexural, and the third – torsional (look at fig. 2), or all three forms must be flexural-torsional. The features of the structure determine the forms of self-oscillation. It does not depend on external loads and it is very important dynamic characteristic of the distribution of stiffness properties of the structure [6]. It is revealed that the first mode shape of building is torsion, second is bending-torsional, and the third is flexural. This is due to the incorrect location of the link elements in the building plan.

Fig. 2. The first form of vibrations of the building - torsional.

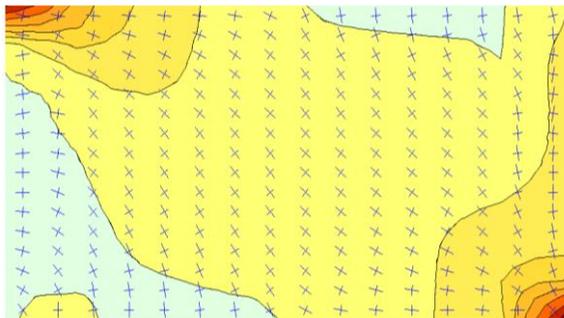
The increase deformability of the building is due to insufficient rigidity of the reinforced concrete frame. The existent connections and diaphragms in the building are placed incorrectly, and as a result, in addition to excessive horizontal movements of the building, there is "twisting" around vertical axis due to the mismatch of the centre of mass and the geometric centre of the building, it exacerbates the manifestation of defects in the enclosing structures. It leads to the formation of excessive distortions of structural cells and, as a consequence, the violation of the exploitation functions of the outer walls, internal partitions of the building, the opening of seams, the formation of cracks, as a result it loses heat and pass noise on residential and non - residential apartments (look at fig. 3,4).

Fig. 3. Map of tensile stress in an ordinary wall. The maximum tensile stress is 38 kN/m².

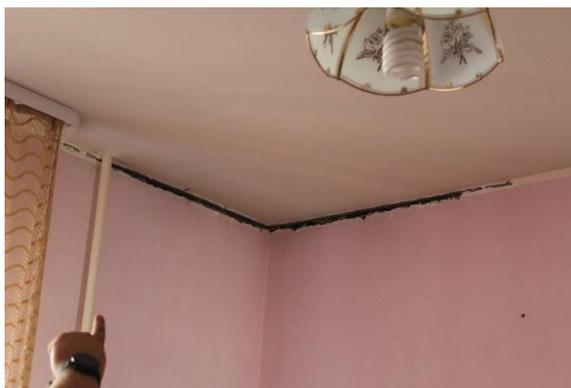
Fig. 4. Examples of cracks that formed between floor slabs and vertical wall filling.

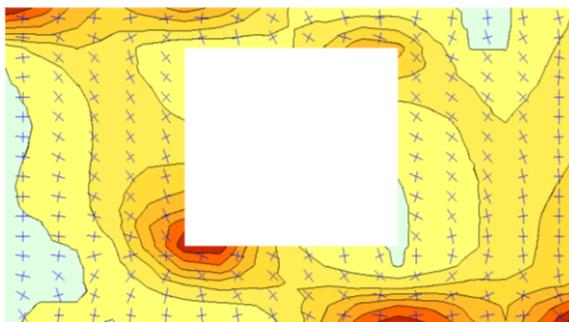
Due to the transfer of loads from the columns to the outer walls, the enclosing structure has cracks which don't provided by the project. These effects are particularly evident in the places of stress concentration – window and door (look at fig. 5, 6).

Fig. 5. Map of tensile stresses in the ordinary wall with a window. Maximum tensile stress is 13 kN/m².

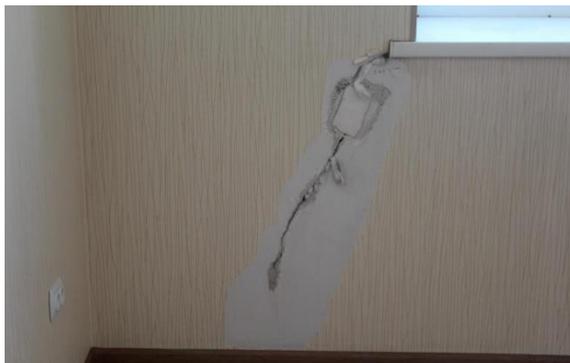
Fig. 6. Examples of cracks that formed in the stress concentration zone in the corner zones of window.
