## Integrity assessment of grouted posttensioning cables and reinforced concrete of a nuclear containment building

**Abstract.** The Containment Buildings of CANDU Nuclear Generating Stations were designed to house nuclear reactors and process equipment and also to provide confinement of releases from a potential nuclear accident such as a Loss Of Coolant Accident (LOCA). To meet this design requirement, a post-tensioning system was designed to induce compressive stresses in the structure to counteract the internal design pressure. The CANDU reactor building at Gentilly-1 (G-1), Quebec, Canada (250 MWe) was built in the early 1970s and is currently in a decommissioned state. The structure at present is under surveillance and monitoring. In the year 2000, a field investigation was conducted as part of a condition assessment and corrosion was detected in some of the grouted post-tension cable strands. However, no further work was done at that time to determine the cause, nature, impact and extent of the corrosion. An investigation of the Gentilly-1 containment building is currently underway to assess the condition of grouted post-tensioning cables and reinforced concrete. At two sel

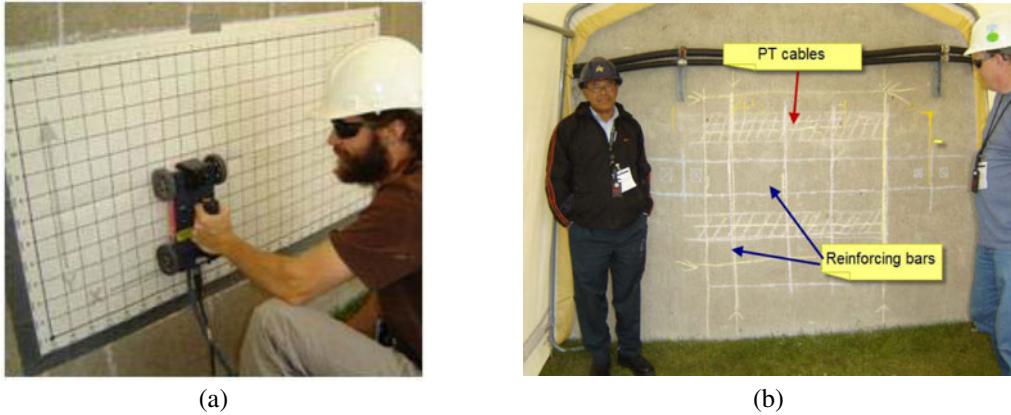
**Figure 3.** (a) GPR to locate embedded parts. (b) Embedded parts marked on the wall.

A Ground Penetrating Radar (GPR) system with three dimensional (3D) imaging capabilities was employed to locate the embedded parts in the wall. A hand held transmitter/receiver was rolled along the vertical and horizontal grid lines to obtain 3D images of embedded steel objects, as shown in Figure 3(a). The GPR system produced accurate locations and depths of embedded reinforcement bars and PT cables. Figure 3(b) shows the location of the embedded parts marked on the wall.

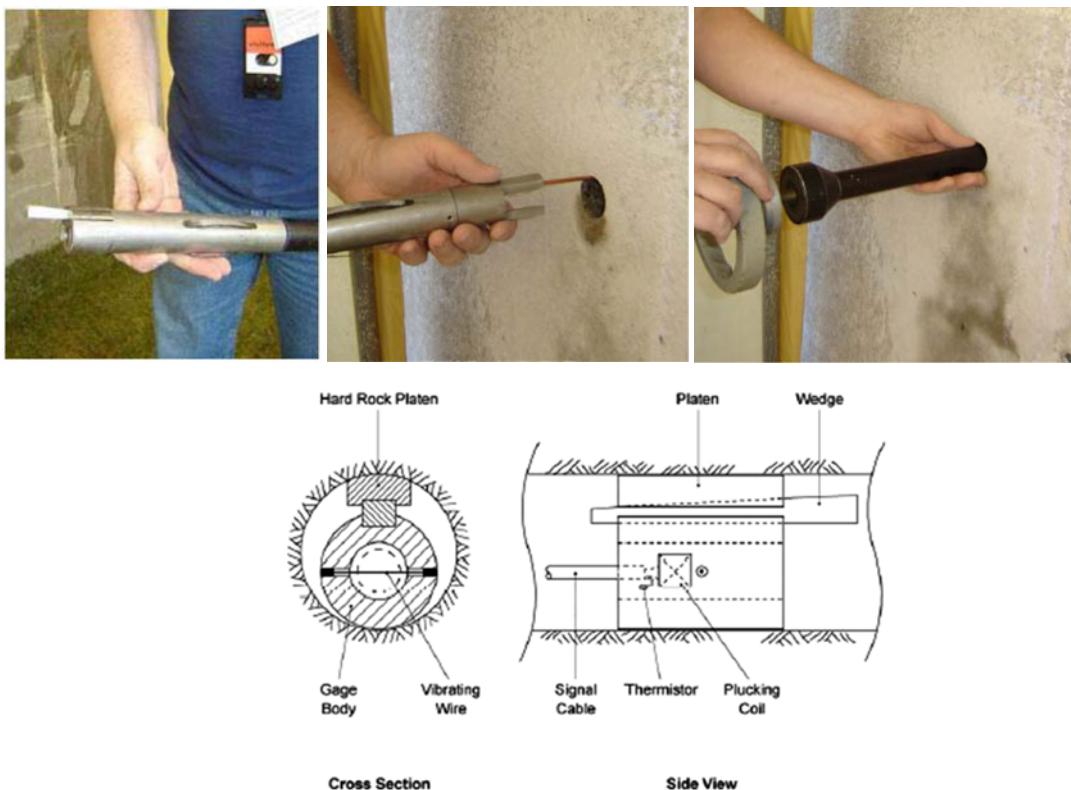
Figure 4 shows one of the VWSM installation tools (the stress meter is held at the tip of the installation tool) prior to inserting in the wall. The holes in the concrete were washed before inserting the stress meters to make sure that it was clean so that debris would not interfere with the performance of the instruments.

**Figure 4.** Pictures showing installation of WVSM in concrete.

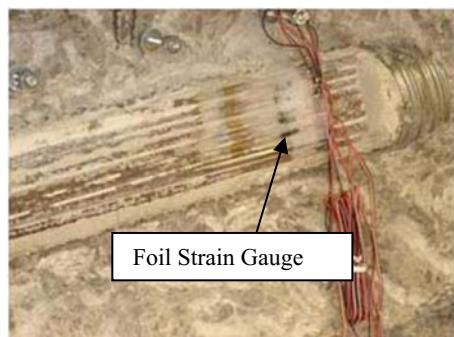
Cutting of the strands resulted in gaps at the location of the cut, ranging from 10 mm to 20 mm in width. The average insitu strain measured in 30 cable strands, that were removed, was approximately 4240 microstrain. Strain gauge readings in showed that stress was transferred from the severed strand to adjacent uncut strands. It was also observed that the grout failed to penetrate in between the strands and did not completely encase all of the strands.

**Figure 8.** Instrumentation of strands before cutting.

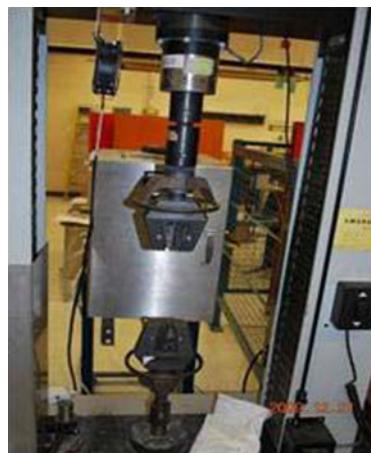
Figure 13 shows the tensile testing machine that was used for the laboratory destructive testing of the cable strands. Three strand specimens were tested and an average yield stress of 1450 MPa and an ultimate tensile stress (UTS) of 1690 MPa were obtained. The stress-strain diagram is shown in Figure 14. The yield and UTS compared well with the design values.

**Figure 13.** INSTRON screw-drive testing machine.
