Vulnerability analysis of a pressurized aluminum composite vessel against hypervelocity impacts

Pierre-Louis Hereil^a, Fabien Plassard, and Jérôme Mespoulet

THIOT INGENIERIE, Route Nationale, 46130 Puybrun, France

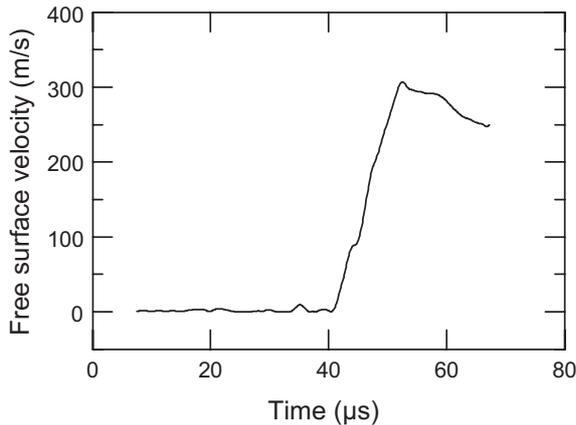
Figure 4. #HE0183: free-surface particle velocity diagram obtained at the rear face of the vessel.

The particle velocity profile obtained with VH metrology at the rear face of the vessel (Fig. 4) shows an increase at a velocity of 300 m/s at time 41 μs after the impact of the projectile on the rear face of the vessel. This value of velocity corresponds to the impact of at least one large fragment on the rear face of the debris cloud generated after the impact. The fragment velocity is estimated at 2300 m/s with this chronometry.

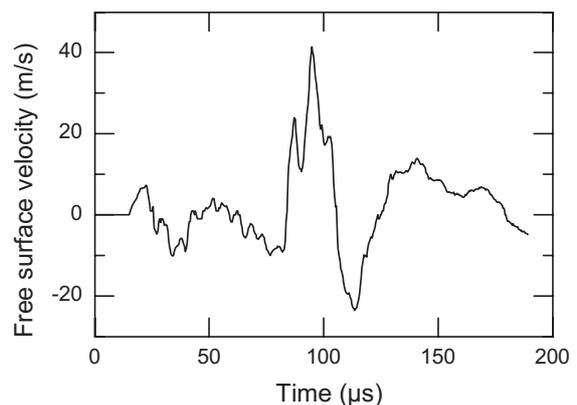
The particle velocity profile obtained with VH metrology at the rear face of the vessel (Fig. 7) has an oscillating shape. The maximum value corresponds to a velocity of 40 m/s at time 95 μs after the impact. This value of velocity is about eight times lower than the equivalent value obtained during the previous test. This leads to the conclusion that the debris are slowed down by the pressurized gas.

Figure 7. Test #HE0184 (N₂ pressure of 200 bar): Free surface velocity diagram obtained at the rear face of the pressurized vessel.

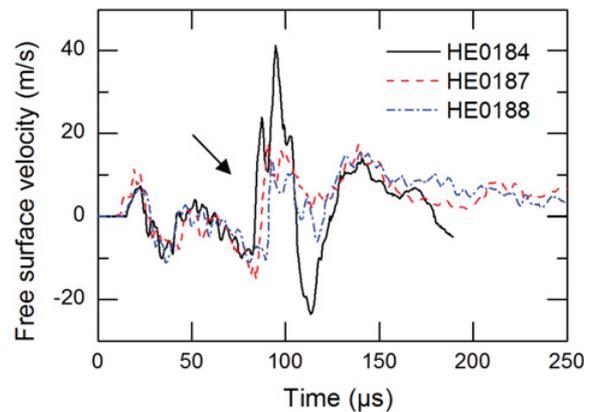
The particle velocity profiles obtained with VH metrology at the rear face of the vessel (Fig. 12) have an oscillating shape similar to the previous test. The maximum value corresponds to a velocity of 18 m/s at time $95 \mu s$ for test #HE0187 and 16 m/s at time $94 \mu s$ for test #HE0188.

Figure 12. Free surface velocity diagrams obtained at the rear face of the pressurized tank for the three tests with pressurized vessels.

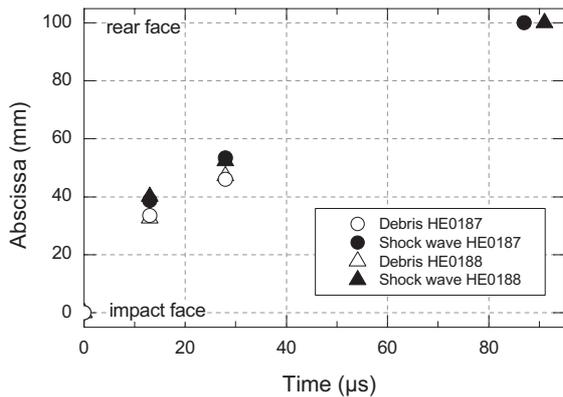
Figure 13. Evolution of the shock wave velocity and the debris in the N2 pressurized vessels.

Measured points for test #HE0187 and test #HE0188 are plotted in a XT diagram in Fig. 13. Abscissa corresponds to the distance in the vessel from the impact face up to the rear face. Open points correspond to debris and black points to the shock wave in pressurized nitrogen. Three points have been selected: first radiography, second radiography and free surface velocity profile. For this last point, the time of arrival has been identified with the third wave at a time between 90 μs and 100 μs (arrow in Fig. 12). This last point is an hypothesis which has to be confirmed by complementary measurements. Nevertheless, this diagram shows the consistency of the measured points.
