# Analysis of photoelastic stress fields in beam

**Abstract.** We have investigated the stress state of models of beams with damage in the form of cuts, simulating the vertical and inclined cracks. The experiments were performed in pure and direct lateral bending. The crack was located in the tension zone model of a beam of piezooptical plexiglass. To study was used method of the photoelasticity. Was ended collating of the stress fields in models of beams with reinforcing layer of carbon fiber and in its absence.

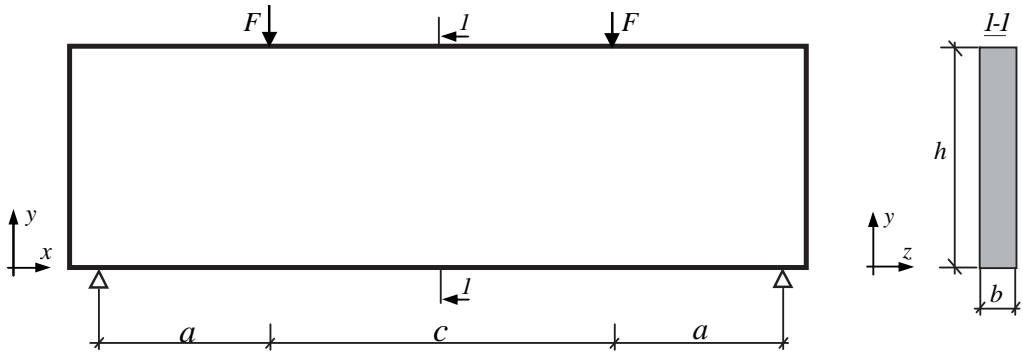
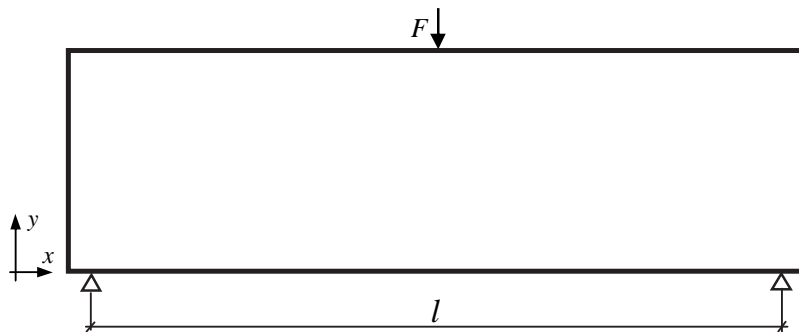
**Fig. 1.** Scheme loading beam: a) pure bending; b) direct cross-bending;  
 $l = 8$  cm,  $h = 1.8$  cm,  $b = 0.5$  cm,  $c = 5$  cm,  $a = 1.5$  cm

without damage. In pure and direct lateral bending (Fig. 1) tested the above model. Then on the lower contour of the samples with epoxy was glued layer of carbon fiber (layer thickness was 0.55 mm, including a layer of glue). In addition, the whole procedure was repeated again.

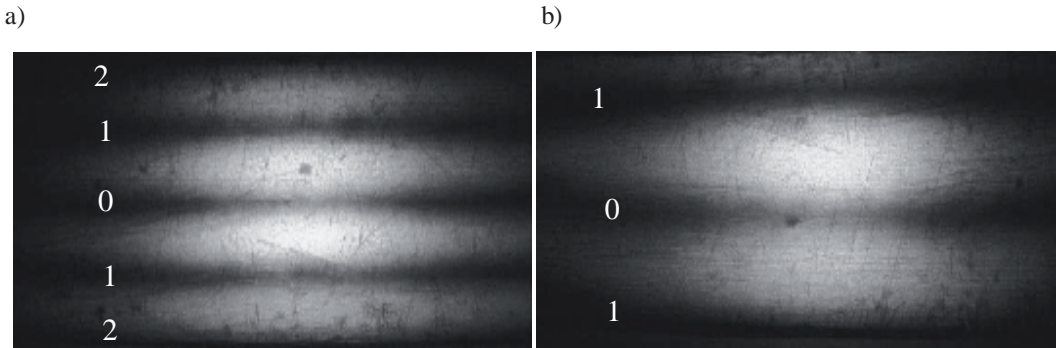
**Fig. 2.** Pictures of the interference bands in pure bending,  $F = 0,123\text{kN}$ :  
 a) model of the beam without carbon fiber, b) model of a beam with carbon fiber

Using the method of photo elasticity was obtained pictures of the interference bands, which are directly related to the differences of principal stresses  $\sigma_1 - \sigma_2$ . Figure 2 shows fragments of photographs of paintings of the interference bands in pure bending in the beam without the reinforcing layer (Fig. 2a) and in the beam with reinforcing layer of carbon fiber (Fig. 2b). Figures in the photos 1, 2, 3, ... - is orders of interference bands.

For pictures of the interference bands (Fig. 2) shows that the order of bands on the contour in the tension zone model of a beam with a reinforcing layer is much lower. The order of the band on lower contour of beam without carboplastic was constitute 2 (Fig. 2a), and the order of the band in the lengthy zone of the model of the beam with inforced layer is less in two ones (Fig. 2b). The introduction of carbon-fiber stress decreased by 53% compared with the voltage in the model of the beam without the reinforcing layer.

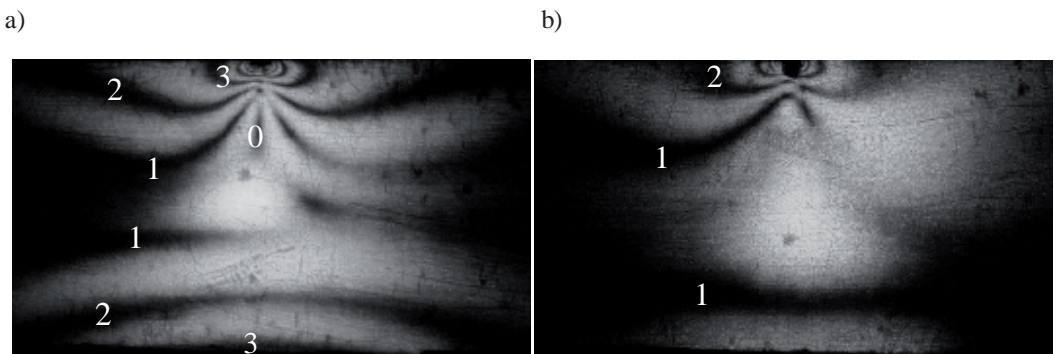
**Fig. 3.** Pictures of the interference bands in the direct lateral bending,  $F = 0,147\text{ kN}$ :  
 a) model of the beam without carbon fiber, b) model of a beam with carbon fiber

Fig. 3 shows photographs of paintings of the interference bands in the direct lateral bending for a beam without carbon fiber (Fig. 3a) and for the sample with the supporting layer (Fig. 3b). This allows you to see the change of the stress field arising in the model with the introduction of the reinforcing layer.

In direct lateral bending (Fig. 3) difference between the stresses on the contour model in the tension zone significantly, the difference is 55%, that means: introduction of the reinforcing layer reduces the stress.

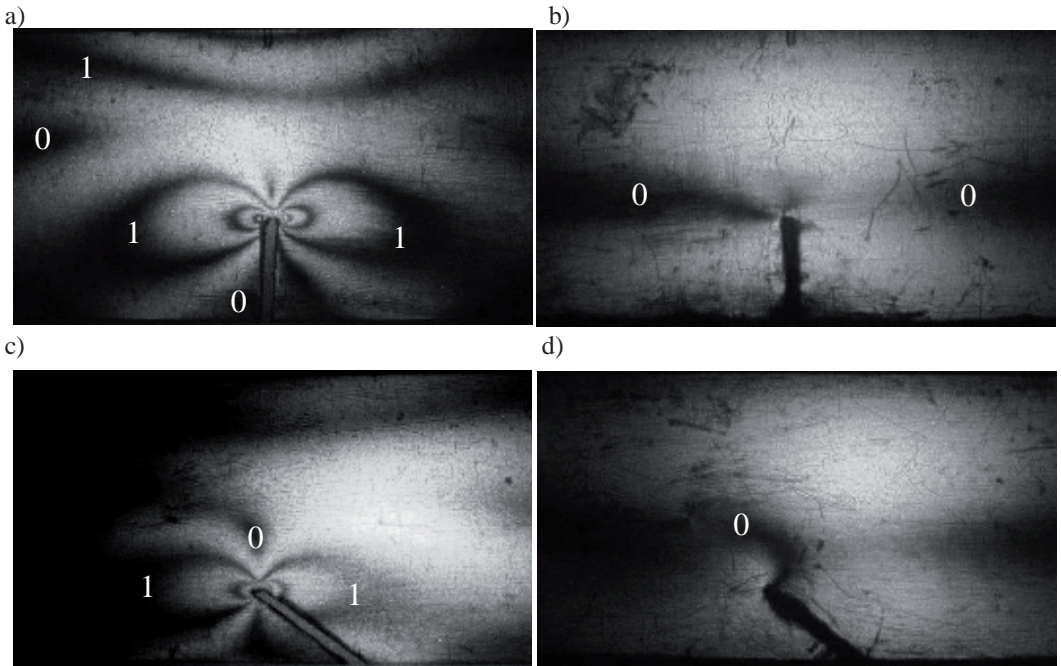
**Fig. 4.** Pictures of the interference bands in pure bending,  $F = 0,074$  kN. Model of a beam with cuts on the vertical axis of symmetry: a) without carbon, b) with carbon fiber. Model of a beam with an inclined cutting: c) without carbon, d) with carbon plastics

Fig. 4 and 5 shows fragments of photographs of paintings of the interference bands in the models of beams with damage in the form of cracks, cuts in the light of the reinforcing layer of carbon fiber and without it. Figure 4 shows the results of an experiment conducted in pure bending, as in Fig. 5 - with the direct cross.

Analysis of the stress fields shows that stress concentration with summit of the inclined crack is lower than with the same load with vertical cut.

The pictures show a sharp decline in the number of lines in amplification patterns carbon. In pure bending at the crack tip-cut on the vertical axis of symmetry of the introduction of carbon-fiber stress decreased by 93%, and the direct cross - at 88%. Near the top of the inclined crack with increased voltage drop was in pure bending 80%, and in the case of direct cross - 84%.

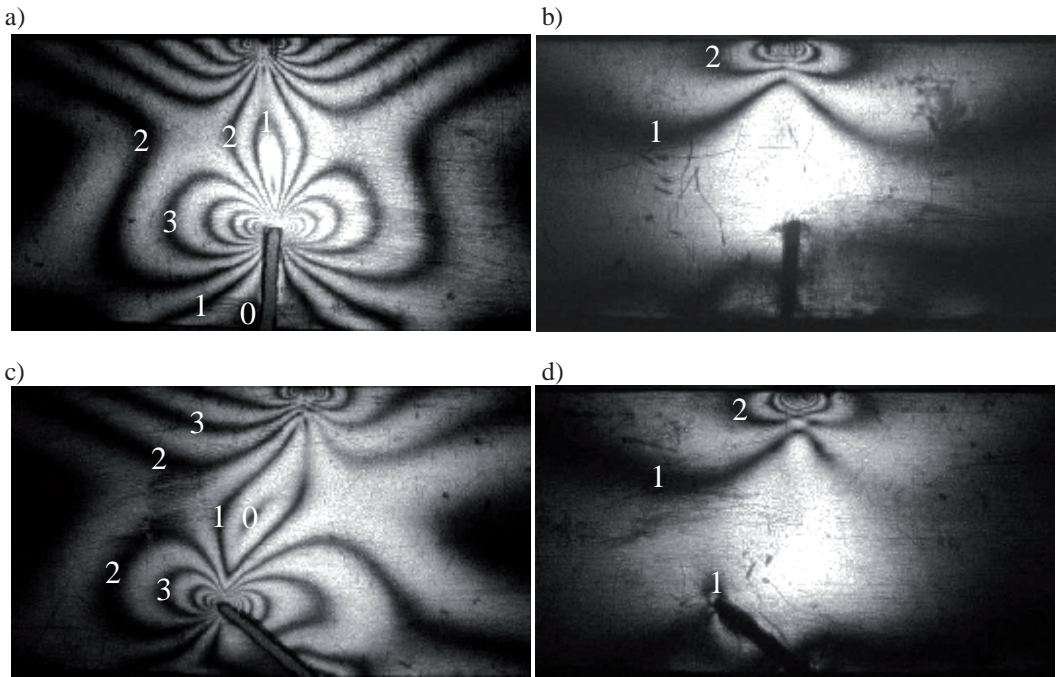
**Fig. 5.** Pictures of the interference bands in the direct lateral bending,  $F = 0,147$  kN. Model of a beam with cuts on the vertical axis of symmetry: a) without carbon fiber, b) with carbon fiber. Model of a beam with an inclined cutting: c) without carbon fiber, d) with carbon plastics
