Observations of corrosion pits and cracks in corrosion fatigue of high strength aluminum alloy by computed-tomography using synchrotron radiation

Y. Nakai^{1,a}, and D. Shiozawa¹

¹Department of Mechanical Engineering, Kobe University, 1-1, Rokkodai, Nada, Kobe, Japan

Abstract. Measurements of the shape and dimensions of the pits and cracks formed in corrosion fatigue tests of a high-strength aluminium alloy, 7075-T651 were conducted by computed-tomography using ultra bright synchrotron radiation X-ray. Complex corrosion process could be observed and detail shape of corrosion pits could be identified. Sometimes, corrosion pit was formed under passive film, and those were not observed from the surface.

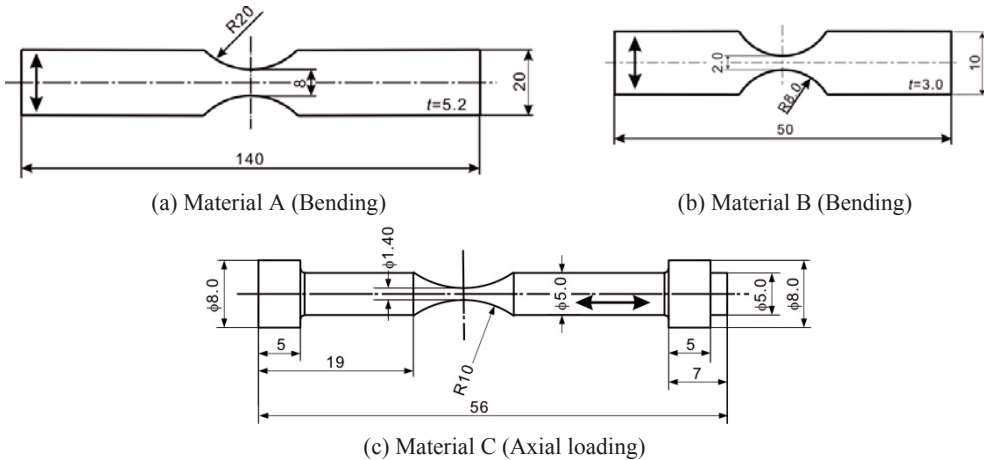
Fig.1 Shape and dimensions of specimens (in mm, Arrows indicate rolling direction).

The materials employed for the present study was a high-strength aluminium alloy, 7075-T651. The chemical compositions and mechanical properties of the alloys are shown in Tables 1 and 2, respectively. The shapes of the alloys when they were received were plates with thickness of 11 mm and 3.0 mm for Materials A and B, respectively, and it was round bar with diameter of 10 mm for Material C. The shapes and dimensions of the specimens are shown in Figure 1. A computer controlled electro-dynamic test machines were employed for the fatigue tests, where cyclic bending was applied to Materials A and B, and cyclic axial-force to Material C. Fatigue tests were conducted in 3.0% NaCl solution at a stress ratio, R , of -1, with loading frequency of 30 Hz for Materials A and C and 20 Hz for Material B. The corrosion chambers are shown in Figure 2. It was made of silicone rubber tube for Material B, and heat shrinkage tube for Material C. The corrosion fatigue tests for Material A were conducted in our pervious study to observe formation of pits by AFM, but it was not employed for the present CT observation. The $S-N$ curves for Materials A and B are shown in Figure 4. The corrosion fatigue life of them is almost identical.

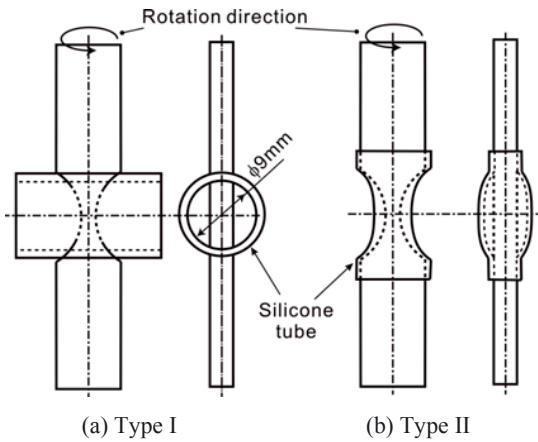
Fig. 2 Corrosion cell for Material B.

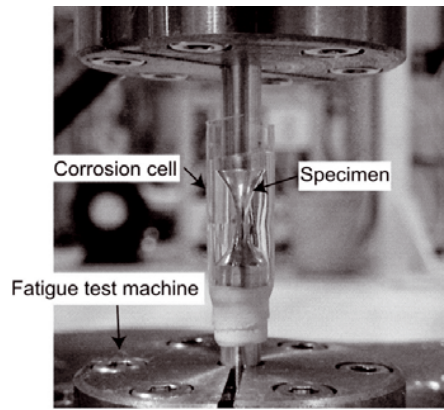
Fig. 3 Type III corrosion cell for material C.

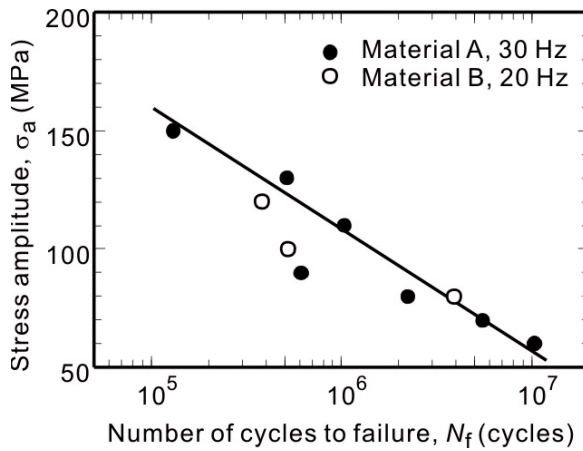
Fig. 4 S-N curve in 3% NaCl solution.

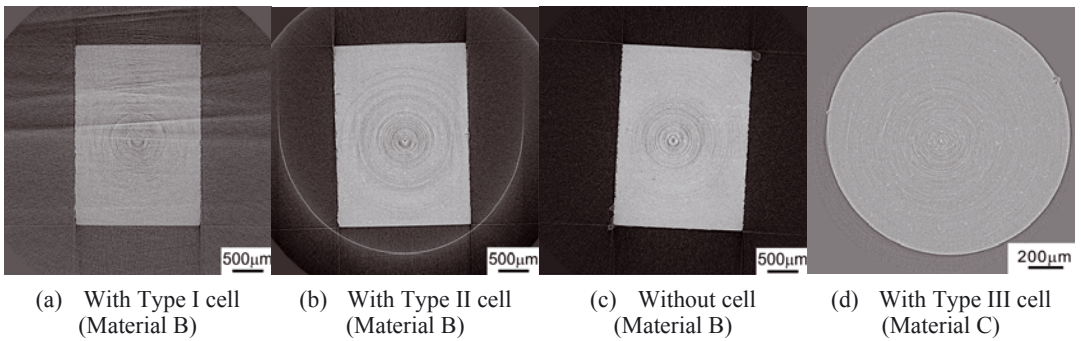
Fig. 5 Effect of corrosion cell on CT imaging.

sample in the solution. For examining how the existence of corrosion chamber affects the reconstruction image, three types of corrosion chamber were employed. The results are shown in Figure 5, where (a), (b), and (c) are images from the rectangular cross section sample (Material B), and (d) is that from the circular cross section sample (Material C).

The cross section image of CT with Type I and Type II chambers are shown in Figures 5 (a) and (b). For Type I chamber, artifact, which crosses the section of the sample, appears although the artifact exist only outside of the sample in Figure 5 (b) for Type II chamber. The difference between Types I and II chamber is that in X-ray penetration thickness of the chamber is almost constant for Type II chamber, and it is not for Type I chamber. The thickness of the silicon rubber changes discontinuously in Type I chamber as shown in Figure 5 (a). There still appear artifacts outside of the cross section of the sample as shown in Figure 5 (b) for Type II chamber although no artifact appears in Figure 5 (c), which was obtained without chamber. The elliptical shape of the cross section of the chamber may have brought the artifact because the penetration thickness of the silicone rubber is not exactly uniform. For Type III chamber, where both chamber and sample have circular cross section, no artifact is appeared as shown in Figure (d) despite only part of the chamber was in the record area.

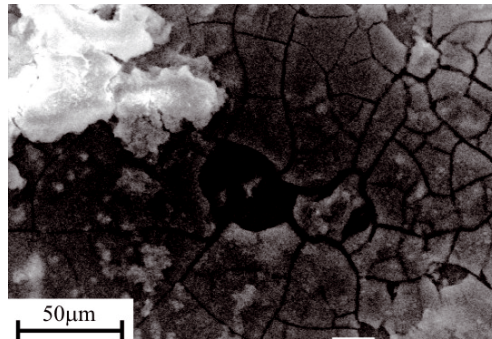
Fig. 6 SEM image of specimen surface ($\sigma_a=80$ MPa, $N_f=4.97 \times 10^6$).

A SEM image of the surface of Material B in corrosion fatigue is shown in Figure 6. The surface is covered with a passive film, and the film is cracked and shows hexagonal pattern, where some part of the film is peeling off. An example of CT images of the same specimen are shown in Figure 7, where (a) and (b) is in a passive film, (c) is near the interface between passive film and base metal, and (d) is in base metal. Small cracks are also observed in the passive film layer observed by CT. It is important to note that the corrosion pits exist under the passive film, those were not found by the conventional microscopy. After 5×10^4 cycles from this observation, the passive film was peeled off and the pit could be observed by optical microscopy. In this alloy, successive formation and peeling off of the passive film was found.

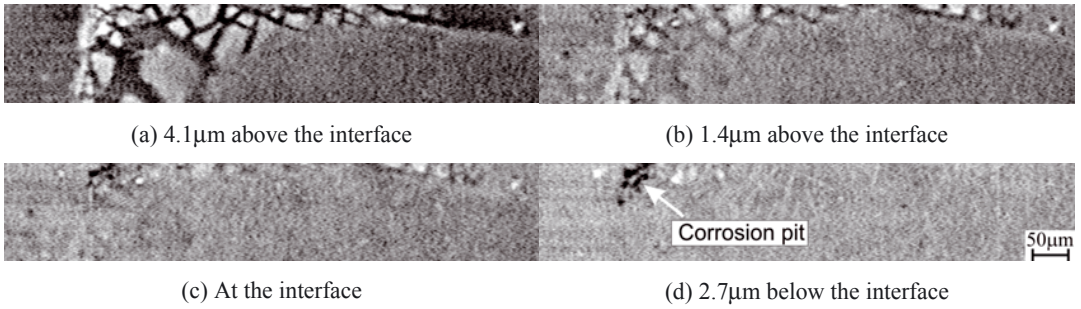
Fig. 7 CT images ($\sigma_a=120\text{MPa}$, $N=3.5\times 10^5$ cycles).

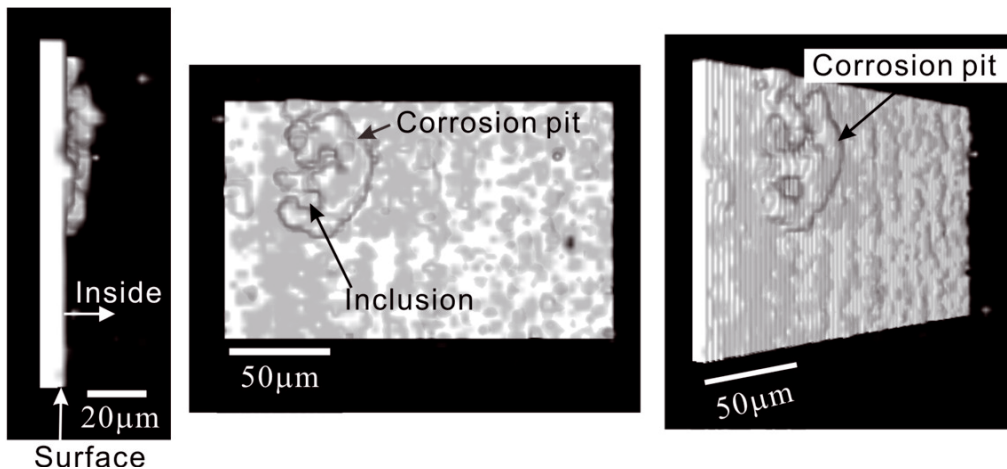
The CT image of corrosion pit was binarized and three dimensionally displayed in Figure 8. This pit was formed from an inclusion and the depth of the pit was $10\mu\text{m}$.

Fig. 8 CT images of corrosion pit in Material B ($\sigma_a=120\text{MPa}$, $N=3.5\times 10^5$ cycles).

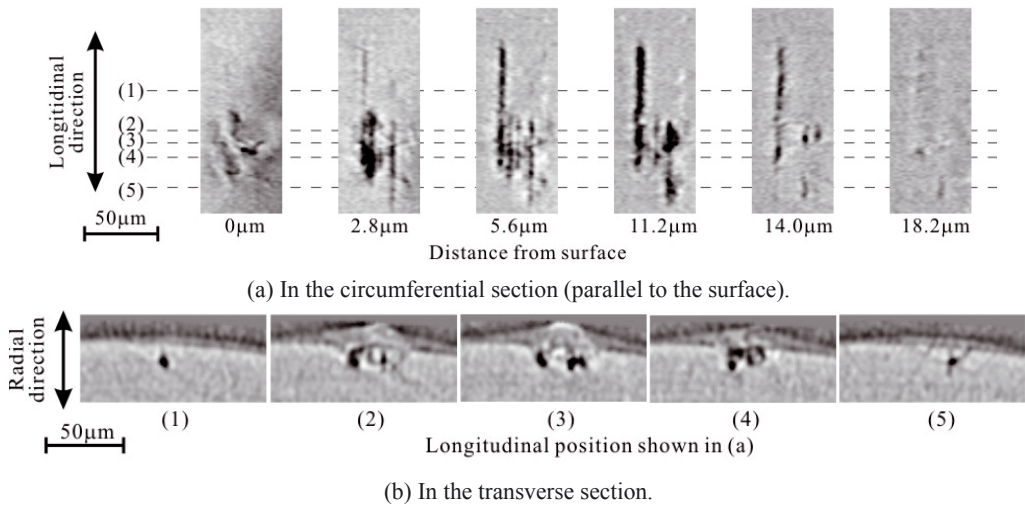
Fig. 9 CT images of Material C ($\sigma_a=115\text{MPa}$, $N=4.9\times 10^5$ cycles).

Detail observations of corrosion pits were conducted by circular cross sectional specimen with diameter of 1.4 mm (Material C). Owing to the slight difference between chemical composition of Materials B and C, the property of passive film is different, *i.e.*, in Material C, hexagonally cracking and peeling off of the passive film were not observed. A corrosion pit formed under stress amplitude of 115MPa at number of cycles, N , of 4.9×10^5 is indicated in Figures 9 and 10, where Figure 9 shows the slice image, and Figure 10 is a three dimensional demonstration of the binarized image. In Figure 9, the corrosion pit extends to the longitudinal direction (rolling direction). Since the pit was covered with passive film on the surface, it may have not been observed from the surface observation by conventional microscopies, but swelling at the pit was recognized. Such swelling has been recognized in the AFM observation of the martensitic stainless steel [3, 4]. Inside of the material, this pit extended like root of plants. It suggests that anodic dissolution occurred along axially elongated inclusions or grain boundary.

Another example of corrosion pit is shown in Figure 11. The shape of the corroded area is similar to that shown in Figures 9 and 10, and the swelling on the surface is more remarkable. These findings indicate that the corrosion speed was high where inclusions reached to the surface.

Growth behavior of corrosion pit, shown in Figure 9, is displayed in Figures 12 and 13. The increase of corroded area and depth with number of cycles (or with time) could be measured from Figures 10, 12 and 13, and the shape of the corrosion pit shown in Figure 13 is similar to that observed by Wei and his co-workers [5].

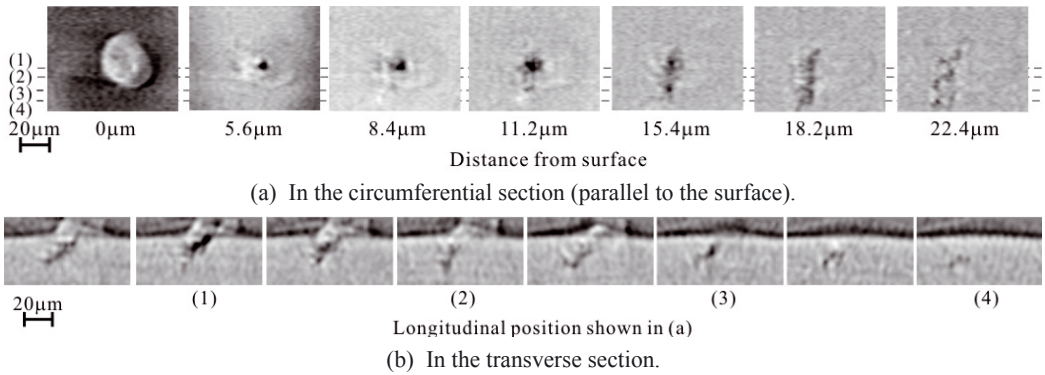
Fig. 11 CT images of Material C ($\sigma_a=115\text{MPa}$, $N=4.9\times 10^5$ cycles).

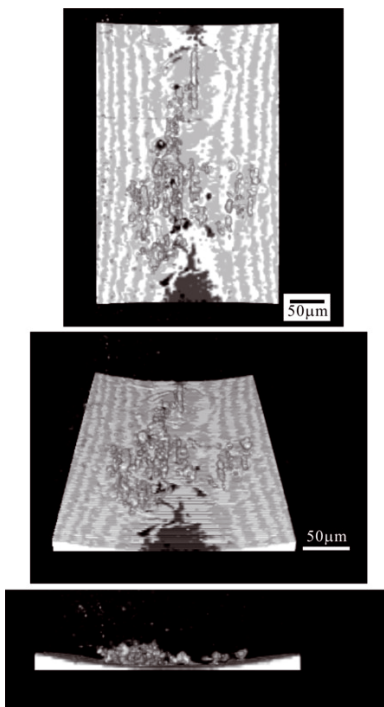
Fig. 12 Corrosion pit ($N=5.94\times 10^5$ cycles).

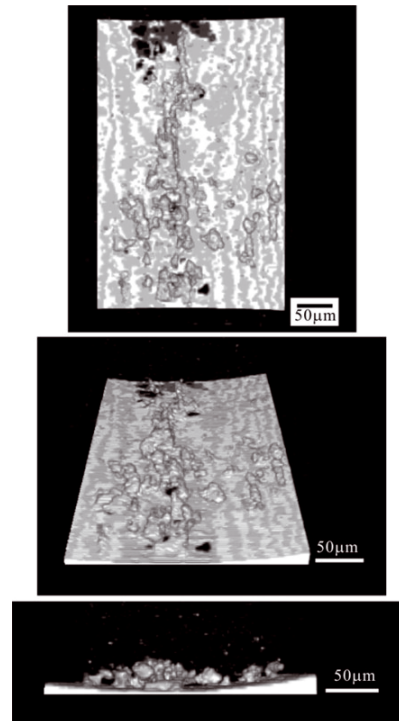
Fig. 13 Corrosion pit ($N=1.24\times 10^6$ cycles).

Initiation process of cracks from corrosion pits shown in Figure 13 is indicated in Figure 14, where CT images of corrosion pit at the crack initiation site before and after the crack initiation is presented. From CT images of specimen surface (x - z plane), which is shown in Figure 14, indicate that crack was not formed from the largest corrosion pit at the surface. Otherwise, it was formed from large corroded area which was not necessarily deep. In the section image (y - z plane) which is perpendicular on the surface, as shown in Figure 14, the corroded region exists inside of the material ahead of the corrosion pit, and a crack initiated at the deepest point of the corroded area, whose depth was $40\ \mu\text{m}$, although the depth of corrosion pit was $12\ \mu\text{m}$.
