# Impact damage evolution under fatigue loading by InfraRed Thermography on composite structures

**Abstract.** This study deals with cumulative damage and its evolution in already impact damage composite structure. In order to follow the growing damage and to compare it with cumulative model, tests are monitored with an InfraRed thermography system. A carbon-epoxy composite is first low-energy impacted and then fatigued under tension-compression loading. This study also enables a very fast analysis of predicting the damage evolution coupling InfraRed Thermography as NDT method and InfraRed thermography as a following system.

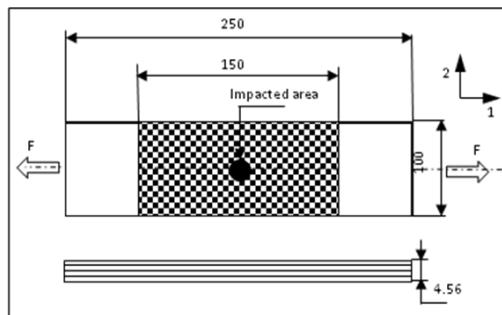
Specimen geometry is as shown on figure 1.

**Fig. 1.** Specimen Geometry used for both tests

According to the standard specifications about fatigue and impact tests [18, 19], a new design of specimen was established. The useful part of the specimen allows the both tests (impact test and fatigue test).

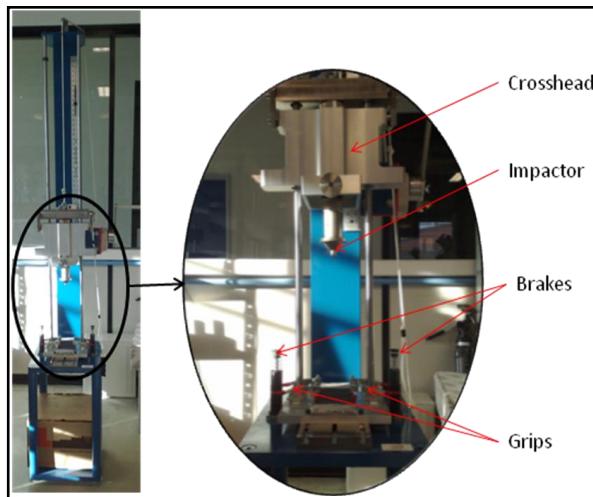
Impact tester is as shown on figure 2.

**Fig. 2.** Impact test machine used for this study

Impact tests were performed with a MTT drop weight machine. A crosshead brake attached to the impactor is used in order to prevent multiple impacts. The used impactor has a hemispherical tap with weights 3 kilograms. According to the standard specifications about fatigue and impact tests [18,19], a new design of specimen was established. The useful part of the specimen allows the both tests (impact test and fatigue test).

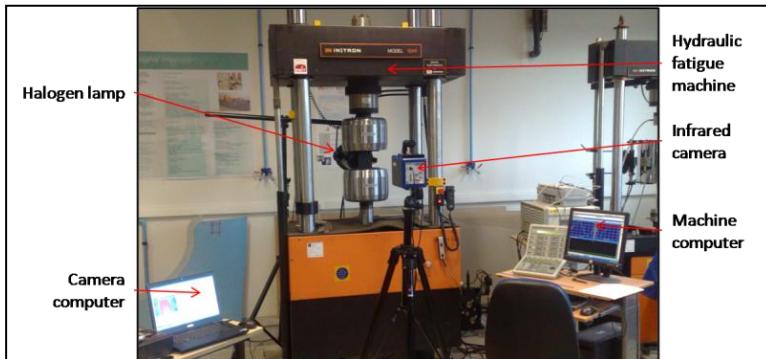
The damage and temperature evolutions were monitored during the fatigue test using an Flir Titanium infrared camera with a sensitivity of 20 mk at 30°C. The thermal movies are recorded at 149 Hz in order to catch the maximum of data as possible. The test is carried out on a controlled temperature and hygrometry room. The protocol of the test is as follow on figure 3.

**Fig. 3.** Fatigue protocol

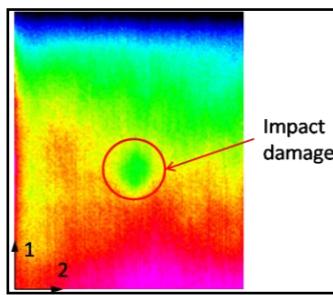
**Fig. 4.** Impact damage

The defect produced on the material is quite hemispherical, like the impactor shape and measurements are 19 mm and 17,5 mm on the direction 1 and 2 respectively.

The 10J impact produced at the centre of the sample created some damages. Most common phenomena appearing during impact testing are matrix crack, delaminations, fibre breakage or fibre splitting at the back face of the specimen. In order to detect damages produced by impact, NDT method is used. For this case, Infrared thermography enables to detect the shape and the dimensions of the produced damage in a short time [14]. A thermal stress is sent to the sample by a halogen lamp. The thermal waves propagate on the material: it creates thermal gradient in it. Because of the difference of the two mediums (composite and defect) coefficient of emissivity, a thermal map is created by the IR sensor. During the heating time, the thermal movie reveals the damage, as shown on figure 4.

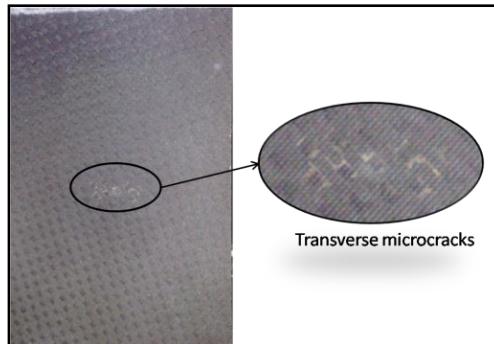
In this part, a sequence of all the visible mechanisms occurred during fatigue testing is presented. After impact, there is no visible indentation on the faces of the sample. After 100000 cycles, transverse cracks reached the front surface.

**Fig. 5.** Transverse microcracks on the front face

The microcracks area grows hardly after 200000cycles and just before failure, fibre breakage appears. After examining of failure, delaminations appears and are oriented on the same directions as fibre directions.

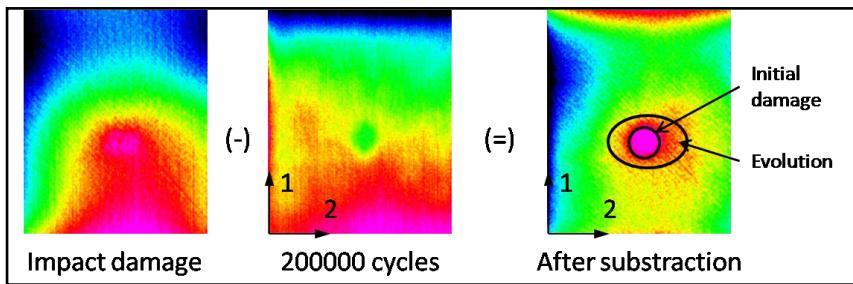
This new method consists in subtracting the initial defect image, revealed by InfraRed NDT methods, to the image caught at the required cycle, as shown in figure 6.

**Fig. 6.** Subtracting method

A new method, consisting in coupling NDT and IR-fatigue enables to have two informations in one image: the initial defect and its evolution during fatigue. NDT methods, as shown in cf 3.1 [14], enables having a thermal map of the defect produced by impact. Following the defect during tension-compression fatigue loading by Infrared thermography outputs a thermal map of the specimen at a known number of cycles.

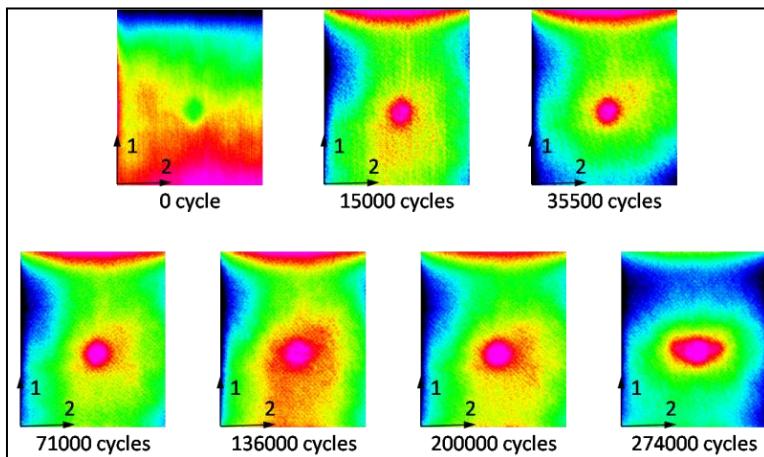
The damage evolution is followed by IR thermography. With the subtracting method, impact damage evolution is performed as shown on figure 7.

**Fig. 6.** Evolution of the impact damage under fatigue loading by IR thermography

As shown of the figure 7, the damage mainly grows on the direction 2. In order to correlate with some other works [13], a plot of the size of the damage, for the two directions, is performed.

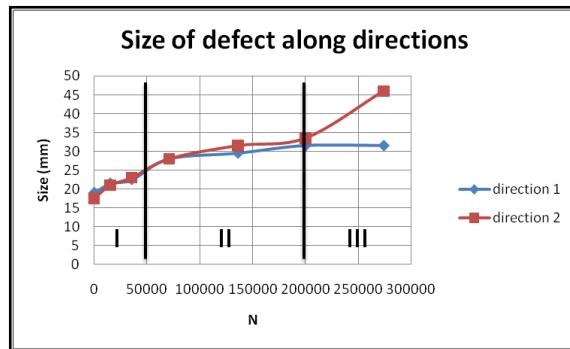
**Fig. 7.** Evolution of the size of the defect along directions

This trend correlates well with the cumulative damage of composite materials with 3 different stages [13].
