Ultrasonic detection of spall damage nucleation under low-velocity repeated impact

Abstract. Repeated plate impact testing with impact stress well below the threshold spall-stress (2.6 GPa) on medium carbon steel was carried out to the identical target plate by impacting the flyer plate. Occurrence of spall damage under low-velocity repeated impact was evaluated nondestructively with a low frequency scanning acoustic microscope. We observed the spall damage distribution by the B- and C-scan images. In order to initiate the spall damage (voids in a ductile material or cracks in a brittle one) the particular value of threshold spall-stress should be exceeded what already belongs to a commonly accepted knowledge. Generally, the spall damage development is dependent on the amplitude and the duration of the stress pulse. If the stress is high and duration is long enough to create tensile failure of material, the voids or cracks nucleate along the spall plane, and consequently, they form macrocracks. Therefore, the spall damage does not create when the first impact stress is less than the threshold spall-stress. However, after the fifth low-velocity repeated impact test, the generation

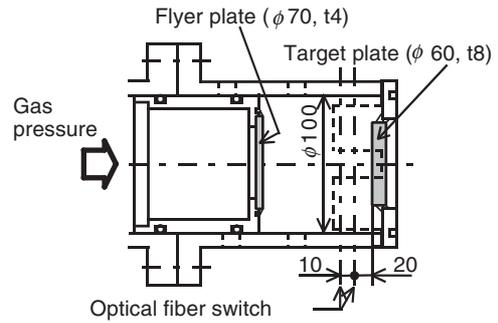
Fig. 1. Location of the target, flyer and the 'velocity measurement unit' denoted in the schematic of the experimental setup. The exact dimensions used in our experiments are indicated in the figure.

Target plate made of medium carbon steel (0.45% carbon) was impacted repeatedly by flyer plate of the same material (the detailed characteristics are given in table 1). The detailed listing of the conditions of the experiments carried out on different specimens is provided in table 2. The dimensions of the used materials and schematic of the experimental setup is presented in figure 1. The parallel

The flyer plate bonded to the plastic sabot was accelerated by a single stage gas gun. The target plate was also bonded to the plastic stage fastened to the target holder and velocity measurement unit (details in figure 1). The velocity of the flyer was measured by the optical fiber switches located 20 and 30 mm away from the target plate. The special recovery chamber has been constructed to recover the target plate with the smallest possible external deformation [4]. The front and rear surfaces of the target plate were polished with a grinder or the #1500 emery paper after each impact test. Repeated impacts were given to the identical target plate with different low impact velocities (see table 2).

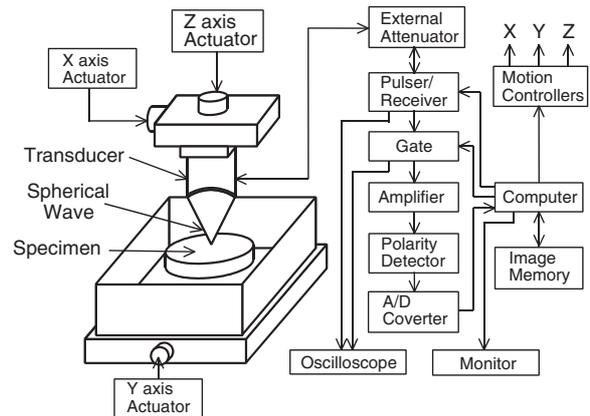
Fig. 2. The clarification of our acoustic microscopy provided in a graphical form.

In order to detect the spall damage occurrence, we used the scanning low frequency acoustic microscopy (SLFAM, Olympus UH Pulse-100 - the schematic given in figure 2, see also refs. [9–11]). The scanning acoustic images were obtained by detection of the amplitude of the longitudinal wave reflected from the elemental area of the specific defects such as inclusions, voids or cracks. The signal intensity registered at each point was mapped as a set of spots of variable brightness (e.g. figure 4 in the Results chapter).

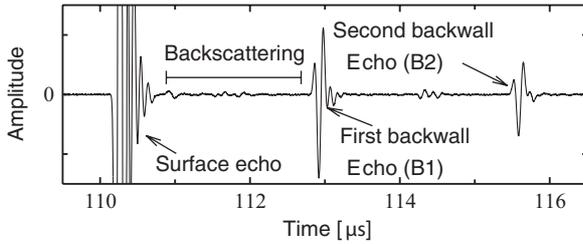
Fig. 3. The typical waveform recorded using the ultrasonic measurement.

In order to quantitatively evaluate the spall damage evolution we determined experimentally a set of pertinent parameters that includes: time-of-flight (longitudinal wave velocity), backwall echo height of target plates (for explanation please find the B1 and B2 parameters in figure 3) and the wave intensity backscattered at spall damage. The employed digital ultrasonic measurement system [13] is composed of ultrasonic pulser/receiver, A/D converter board and personal computer. The longitudinal wave transducer with the 10 MHz frequency and 6.4 mm diameter made it possible to record the wave from the back wall and backscattering echoes at three different locations (in the center as well as 10 mm away), all of these before and right after the impact test.

The careful analysis [details in ref. [4]] of the registered waveforms (depicted in figure 3) enabled us to conclude on the ultrasonic velocity and attenuation (amplitude ratio of B2 to B1 echo). The frequency-dependent backscattering intensity, characterized by the non-dimensional value N :

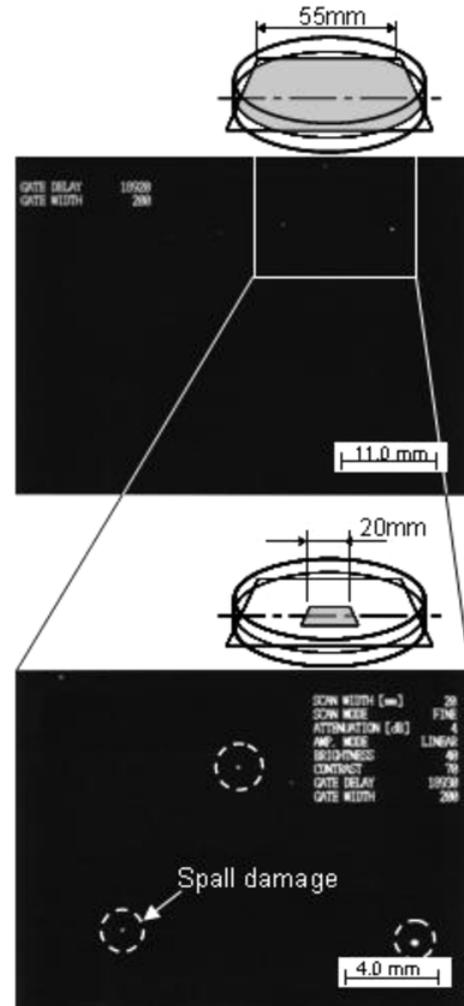
Fig. 4. The spall damage in medium carbon steel generated after the fifth impact during low-velocity repeated impact tests. History of impact stress are 1.2 GPa (first), 1.4 GPa (second), 1.2 GPa (third), 1.5 GPa (fourth) and 1.5 GPa (fifth). The exposed particular data (C-scan image at the 3.3 mm depth) were registered for the sample No.R6.

As a result of the careful observation by the acoustic microscope, the spall damage was detected after the fifth impact [figure 4 (spec. No. R6), White part in the image

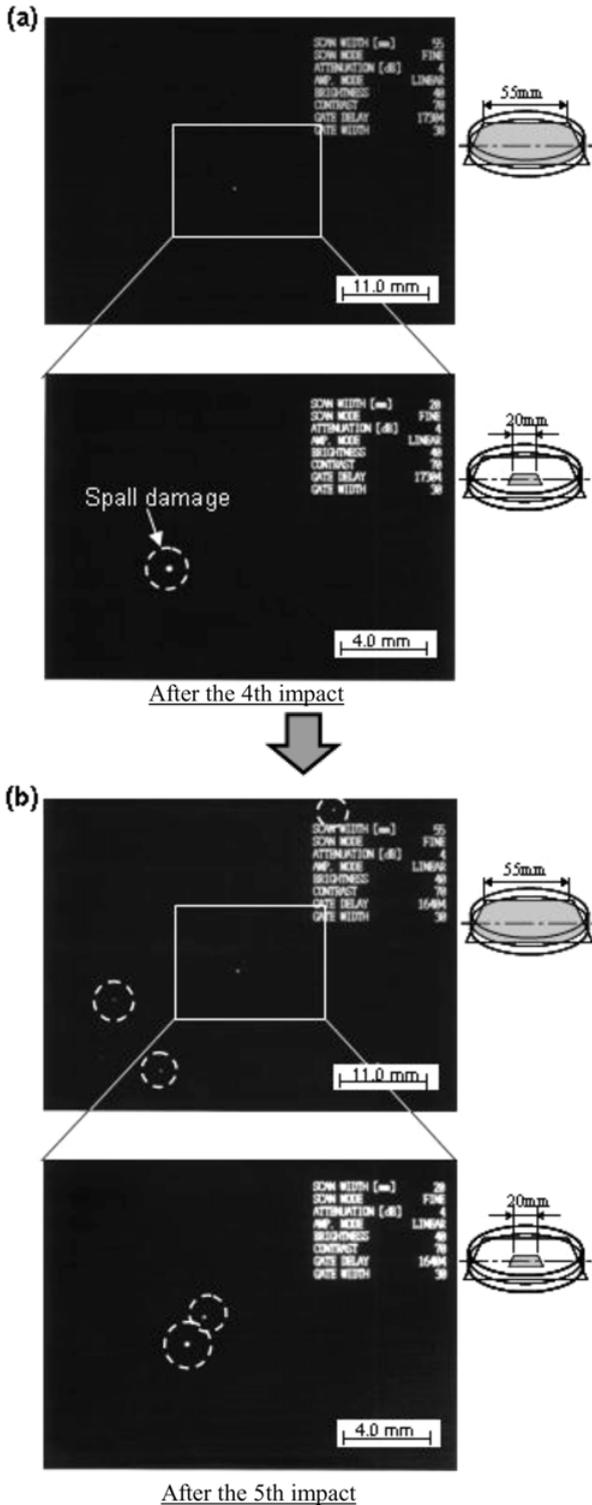
Fig. 5. The spall damage in medium carbon steel generated after the fourth (a) and fifth (b) impact during low-velocity repeated impact tests. History of impact stress are 1.3 GPa (first), 1.7 GPa (second), 1.5 GPa (third), 1.3 GPa (fourth) and 1.3 GPa (fifth). The exposed particular data (C-scan image at the 3.5mm depth) were registered for the sample No.R2. The spall damage nucleated by the fourth impact was increased by the fifth impact.

indicates the defect by reflected signal]. And, in the case of another specimen, the spall damage detected after the fourth impact was increased by the fifth impact [figure 5

(spec. No. R2), It is worth emphasizing that the images refer to the exactly same region of target plate]. Namely, the spall damage is generated by the repeated impact, even if the impact stress was lower than the threshold spall-stress. Nucleation of the spall damage will concerns the history of impact testing and its influence on mechanical behavior.

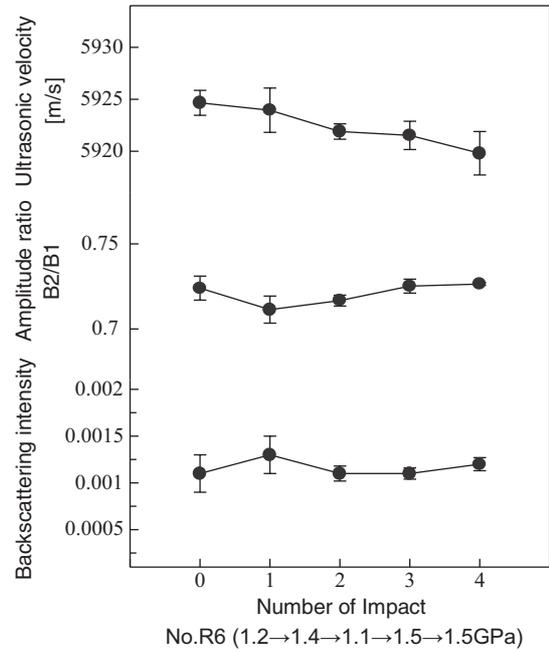
Fig. 6. Changes of ultrasonic velocity, amplitude ratio and backscattering intensity during the low-velocity repeated impact test. The data correspond to C-scan images displayed in the figure 4.

The measurement of the pertinent ultrasonic characteristics was carried out on samples that were exposed to low-velocity repeated impacts (e.g., for No. R6). Especially in the ultrasonic characteristics, the ultrasonic velocity slightly decreases with the increase in the impact number, as shown in figure 6. However, it was not possible to obtain the clear change of each ultrasonic variables of the every impact test for the quantitative evaluation of the damage, owing to the extremely minute and small amount of the spall damage nucleated in the specimen. These authors will make an attempt other ultrasonic methods for quantitative evaluation of generation of smaller, microscopic defects,
