# Drone-based solar panel inspection using machine learning

**Abstract.:** The paper represents the experimental implementation of a Drone-based solar panel inspection using YOLOv8-based object detection with Ultraviolet sensing for automated and enhanced defect inspection. A quadcopter platform was equipped with imaging sensors that was used to capture aerial images of the solar panels. The dataset used consists of 1500 annotated images categorized into clean panels, surface cracks, dust accumulation and thermal defects. The YOLOv8 model was fine-tuned using the dataset which had an input of 500x500 resolution for training a series of 100 epochs. Transfer learning enabled object localization and classification and RGB-based detection, for effective detection and identification of abnormal surfaces, discharge related anomalies where identified successfully that cannot be identified through standard imaging. Experimental validation also demonstrated reliable detection across all categories of defects and the results validated the completion of the project using lightweight deep learning model for object detection with multiple sensor UAV platform for cost-effective inspection, maki

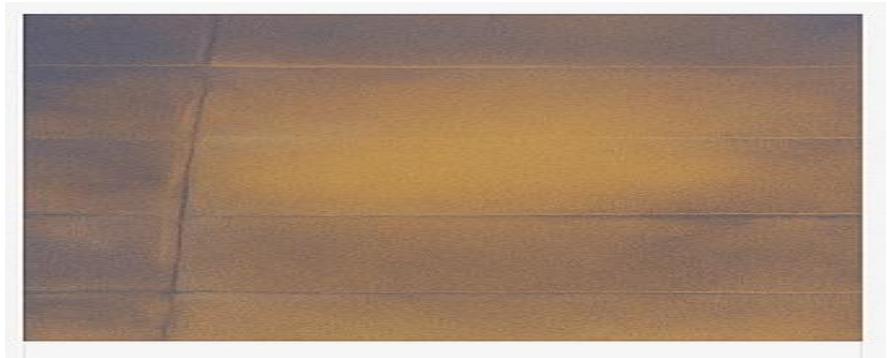
**Fig. 5.** Decoloration

The type of defects that are caused in the encapsulant layer. Over time, the encapsulant layer goes through UV degradation, thermal stress, poor lamination during installation, and moisture ingress, which leads to a discoloration process that often appears as a yellow or brown layer and separation of glass or backsheet, leading to bubble formation or air gaps between the layers of the panels. Often found through Drone visual inspection by usage of normal cameras.

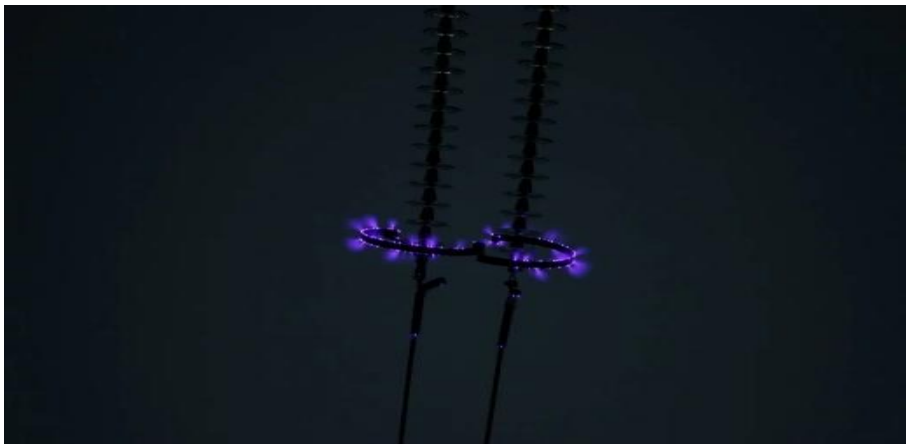
**Fig. 9.** Corona Discharge

Corona discharge most commonly occurs at faulty connectors due to a breakdown in insulation or improper pinching of wires. While PID occurs due to a difference in voltage between cells and the grounded frame. While Corona Discharge defects produce sparks, noise, or emit ozone gas, PID defects can lead to uneven heating and power loss, which can lead to major issues if left unnoticed. With a UV camera-mounted drone, the bright glowing sparks or regions due to corona discharge can be found and PID defects can sometimes appear as thermal anomalies, which require a thermal camera, a UV camera, as sometimes they give out discharges too, or even appear as patches of reduced performance depending on the severity of PID defect.

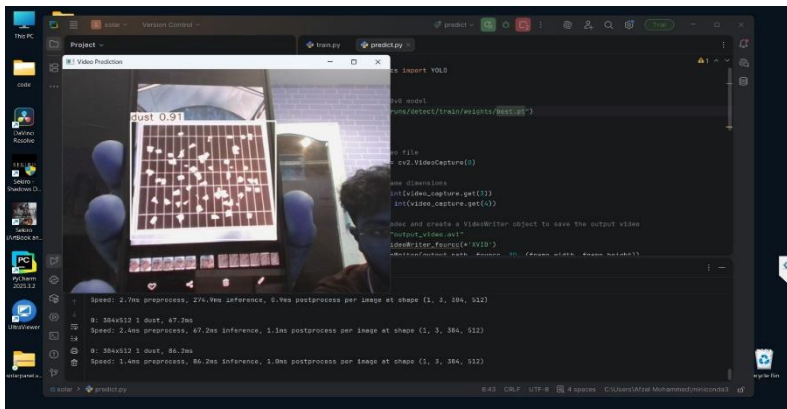
**Fig. 10.** Visual image identification

The system developed was able to detect defects in PV panels using the implemented deep learning model. Thermal imaging and visual imaging helped in the identification of temperature-related anomalies, and surface level defects. The UV sensor was used to identify the electrical discharge defects. The results indicated that the system can perform multi-sensor equipped inspection in an automated and cost-efficient manner, making it suitable for large-scale farms.
